**U.S. PUBLIC LAND CORNER
MAINTENANCE**

**Corner ID : SE Sec.36, T18N-R1W
21801360000**

COUNTY SURVEYOR FORM NO. 1

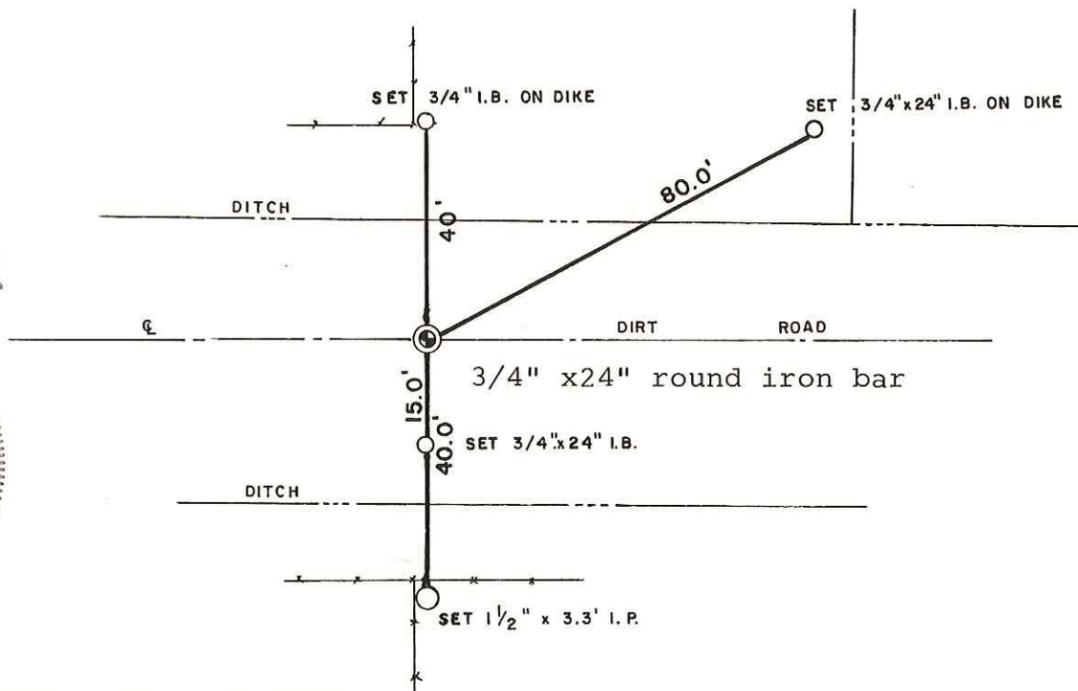
Could not find Holden's monument. Corner re-established in centerline of road and on line with north-south fences.
