**U.S. PUBLIC LAND CORNER
MAINTENANCE**

Corner ID : SW Sec.5, T17N-R1E

41701060000

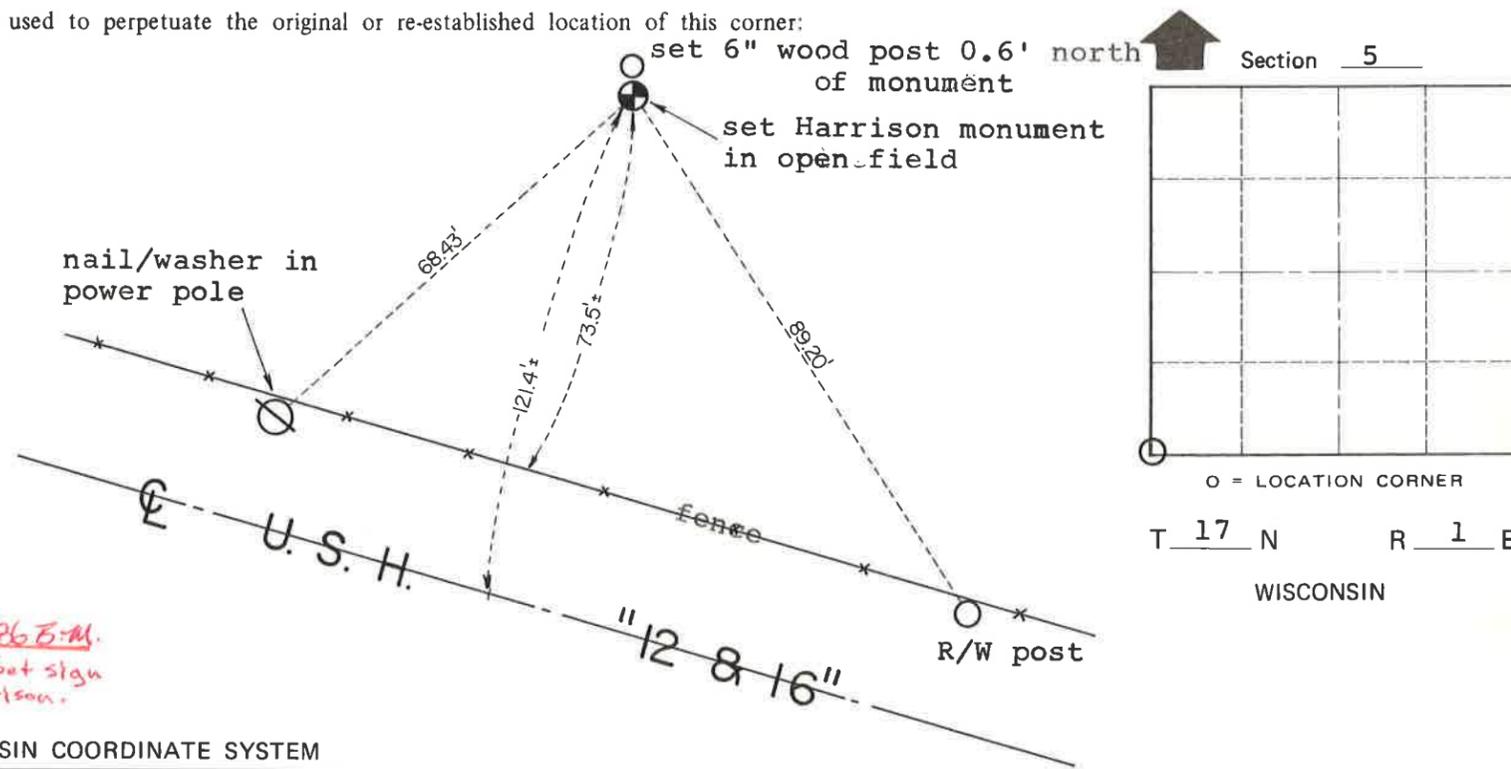
A Harrison monument was set by extending East, on a straight line and doubling the distance between monuments found at the S $\frac{1}{4}$ corner of Sec. 6 and the SW corner of the SE $\frac{1}{4}$ -SE $\frac{1}{4}$, Sec. 6.

Description of corner and witness monuments, references and accessories used to perpetuate the original or re-established location of this corner:
