U.S. PUBLIC LAND CORNER MAINTENANCE

Corner ID: N1/4 Sec. 16, T18N-R1W

21801090020

City, Village or Town La Grange
County of Monroe

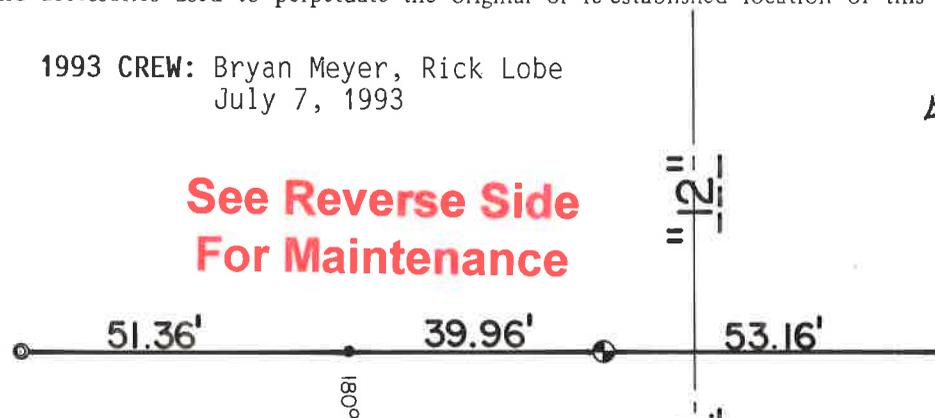
UPDATE: A resurfacing project was to take place in the summer of 1993. Prior to construction, the distances to previous ties were checked and a new tie taken. The Harrison was then removed. Following the resurfacing project, a 1/4" x 30" round iron bar was set at the corner location.

Ex. sign here.

- ⊕ = Set 1/4" x 30" round iron bar
- ⊙ = Set 1/4" x 24" iron pipe
- = Existing 3/4" round iron bar

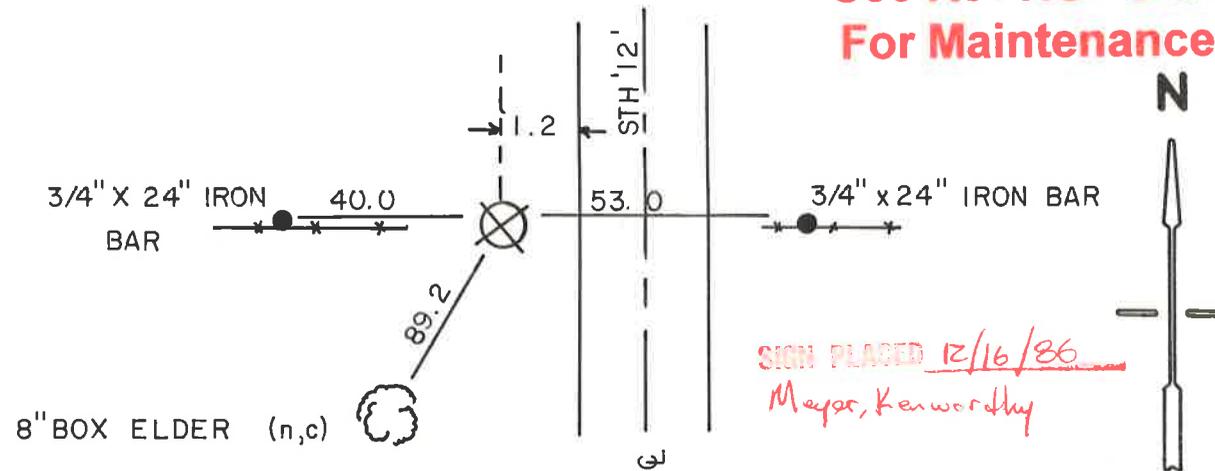
Set standard Harrison monument down 4" below gravel in shoulder of road.
Accessories are as follows :

SIGN PLACED 12/16/86
Meyer, Kenworthy
