INVESTIGATION REPORT FOR COON CREEK WATERSHED STRUCTURES 21, 23, AND 29,  
AND WEST FORK KICKAPOO WATERSHED STRUCTURES MLSNA AND 1  
MONROE AND VERNON COUNTIES, WISCONSIN

U.S. DEPARTMENT OF AGRICULTURE  
NATURAL RESOURCES CONSERVATION SERVICE

June 26, 2019

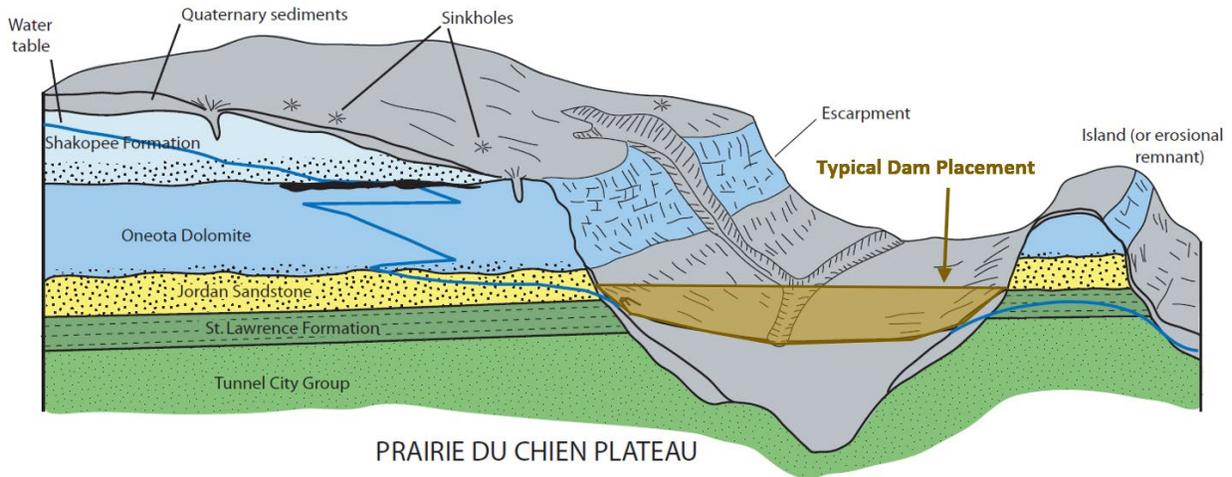
– the Jordan, the St. Lawrence, and the Lone Rock Formation of the Tunnel City Group, also known as the Franconia Formation (Figures 2 & 3). The primary bedrock unit forming the steep wooded hillsides on the abutments of the structures is the Jordan Sandstone. It is comprised of two distinct lithofacies: the Van Osier Member, which is the upper one, is fine to coarse grained quartz sandstone; and the Norwalk Member, which is the lower one, is a very fine-grained feldspathic sandstone (Mossler, 2008). Based on other project sites in the area and outcrops on site, the Jordan Sandstone is often soft, poorly cemented, and friable, especially near the surface where it is easily weathered into a soft sand (typically a non-plastic sand).

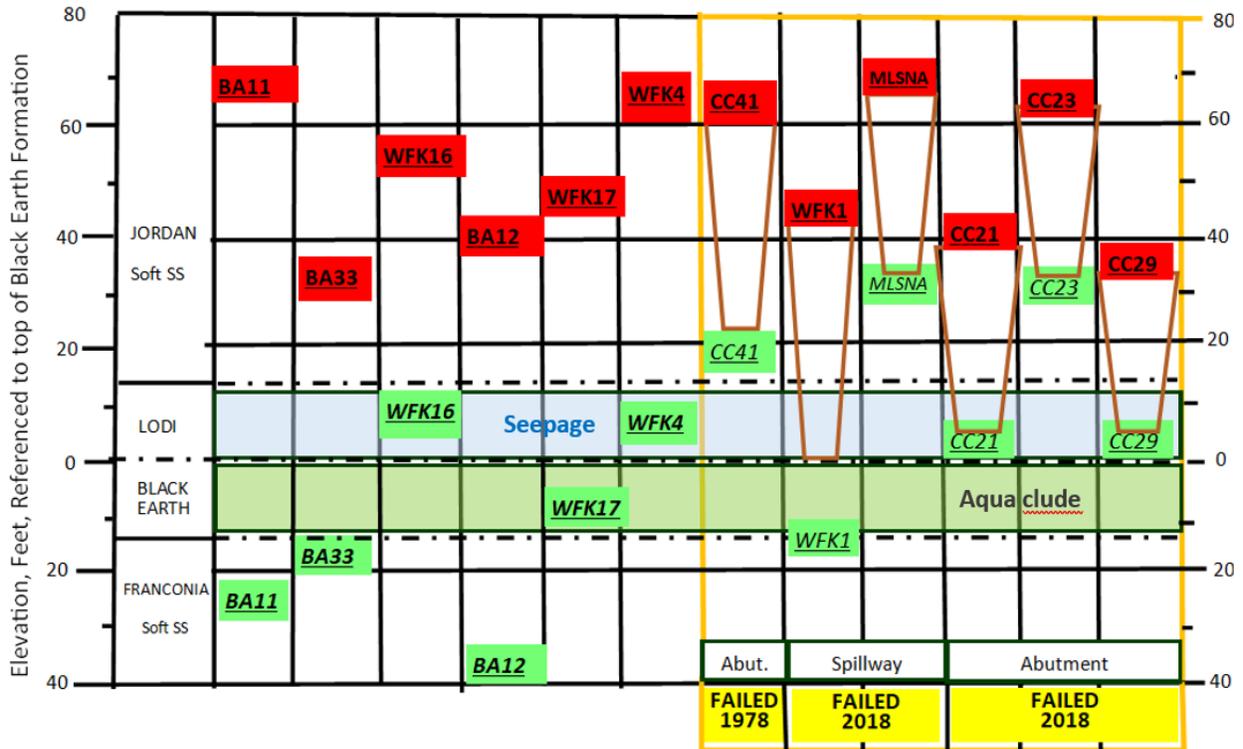
Figure 4- Effective Stratigraphy of selected PL-566 dams in WI. Top of dam elevation shown in red and bottom of core trench elevation shown in green. Brown polygons have been drawn to show the relative elevation of breaches.

Material Strength, Permeability, and Regional Groundwater Flow are important geologic conditions that likely caused adverse effects at the dams. As shown in Figure 4, all five PL-566 structures that have breached in Wisconsin were either in the soft, weakly cemented Jordan Sandstone or the high permeability Lodi Member of the St. Lawrence formation. Experience in this area shows that the Jordan Sandstone weathers to a loose highly permeable non-plastic sand (SM or SP). The previously mentioned materials were expected to be present in the breached zone based on observations on site and as-built interpretations summarized on the drawings in Attachment E.

As shown in Figures 2 & 4, the Black Earth Member of the St. Lawrence formation is a known Regional Aquiclude. This means that whether the dams were built in those locations or not, the local water table would have already been elevated. And so there was a high likelihood of water seepage and springs already occurring at that stratigraphic position.

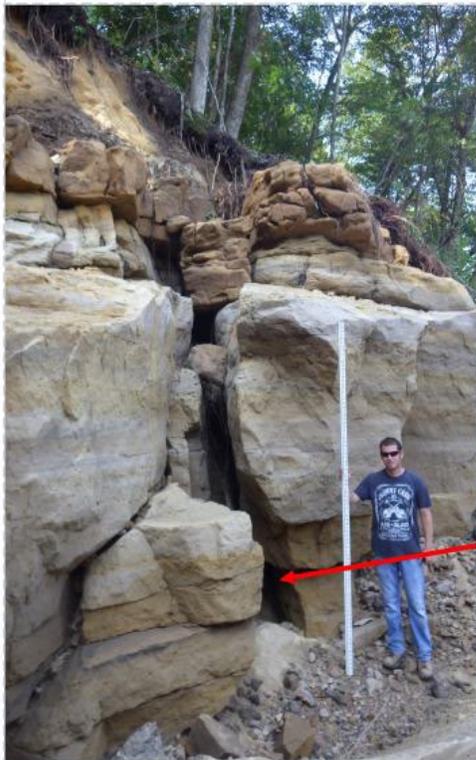
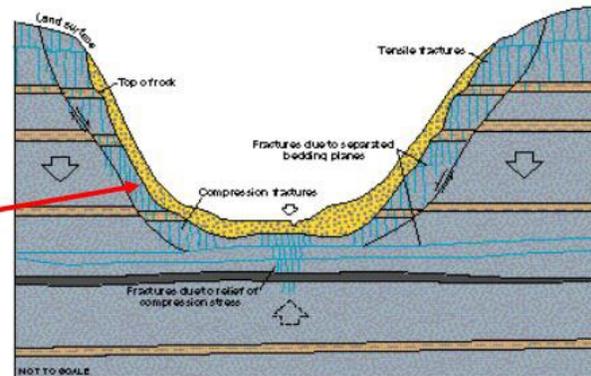
Figure 5 provides an explanation of how valley stress relief fractures form, including a photo of an interpreted valley relief fracture in the wall of the CC-23 abutment. These fractures run parallel to the valley flow direction which make them a likely bypass for the structure.

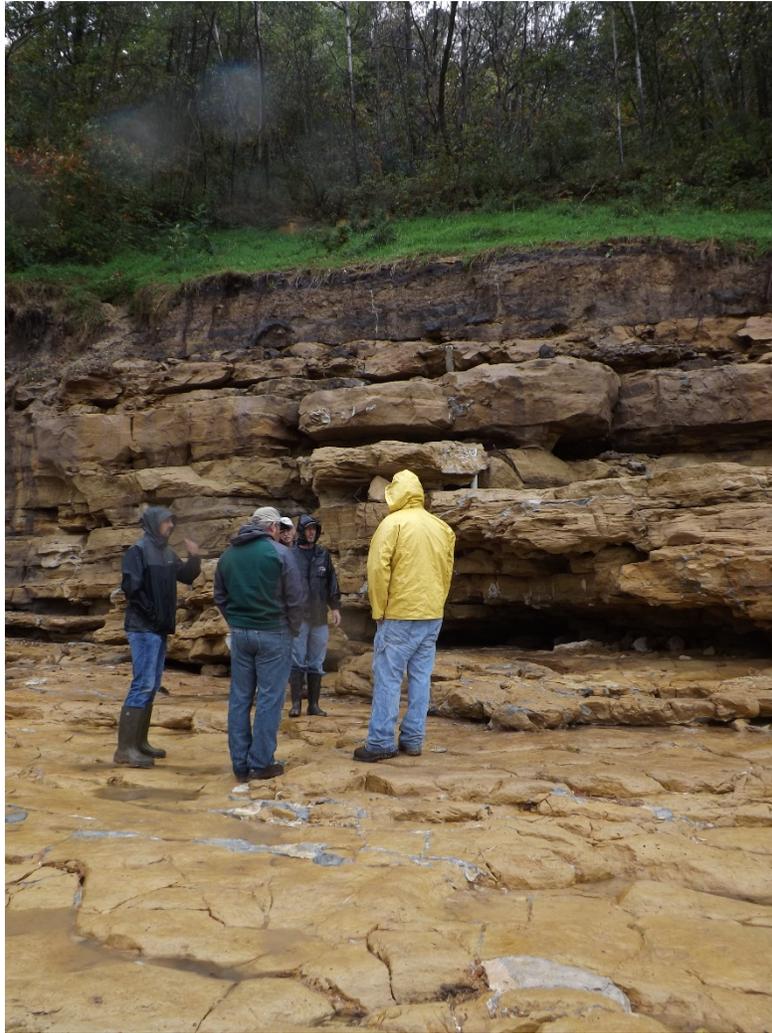
Photo 4

Remnants of the grout holes were observed in the breach channel bottom and abutment slope (see Attachment B, Photos 6 and 7). Some joints were filled with grout, but not all. The grout curtain was not as effective in cutting off seepage on the right side as it was on the left side. But, as noted in the O&M inspection report summary, observed seepage from the drains on the right side decreased following construction of the grout curtain. The committee observed that the grouted bedrock did not collapse as far into the abutment and retained more of its structure at the exposed surface (see Attachment B, Photo 8).

Close up of exposed right abutment near centerline of dam. Grouted fractures in the breach channel bottom and large voids of eroded sandstone in the abutment face.  
(WFK 1)

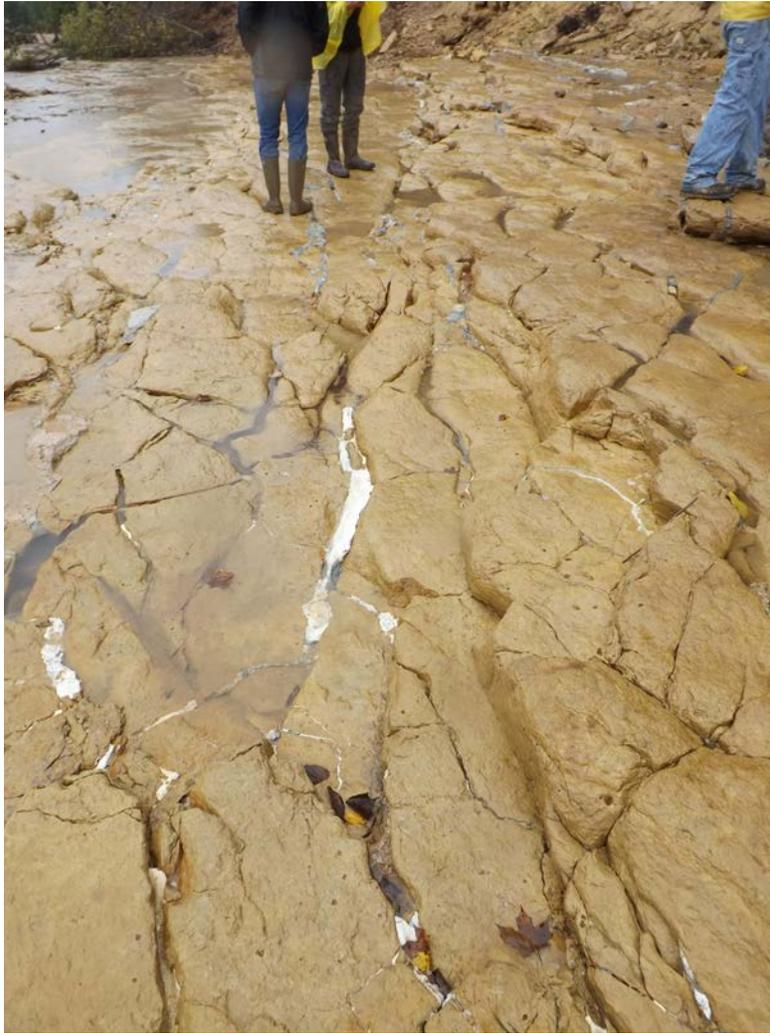
Photo 5

Vertical fractures in exposed bedrock. Note white and gray material is from 2009/2010 pressure grouting.  
(WFK 1)

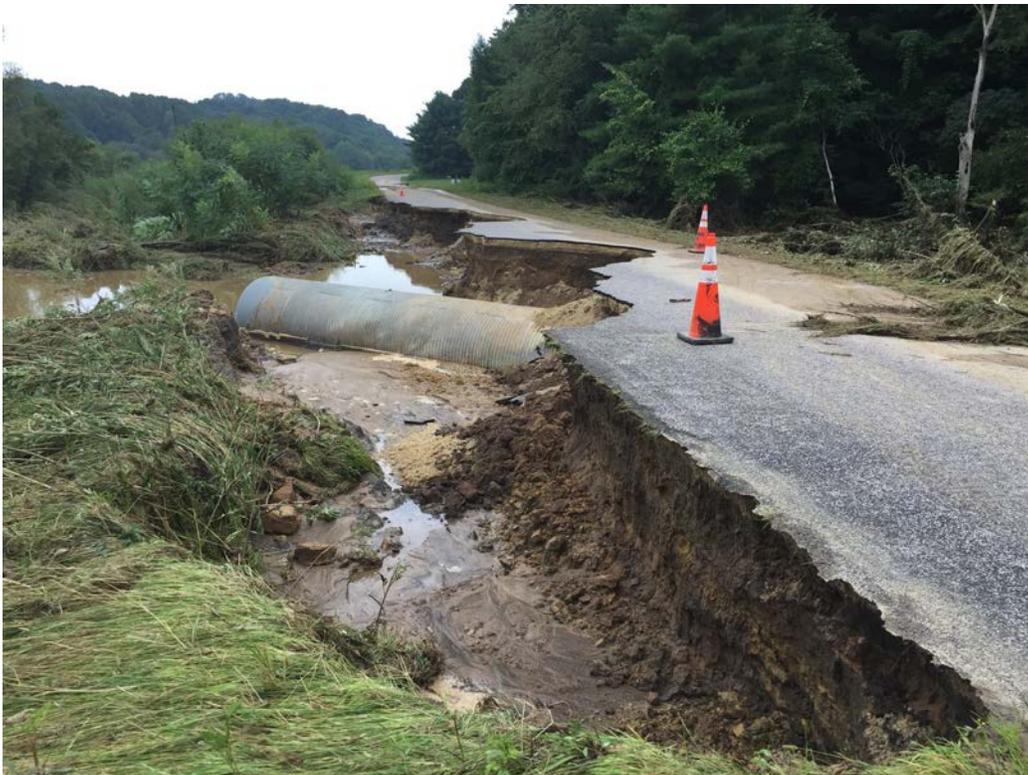
Evidence of a sudden breach on this site is similar to WFK-1 with an extensive debris field downstream consisting of fragments of bedrock material (see Attachment B, Photo 24). There was also extensive damage to a town road in the breach inundation area (see Attachment B, Photo 25). A post-breach survey of the breach channel estimated the of eroded material volume at 18,000 cubic yards.

Photo 25  
Damaged road in breach inundation area.  
(WFK MLSNA)

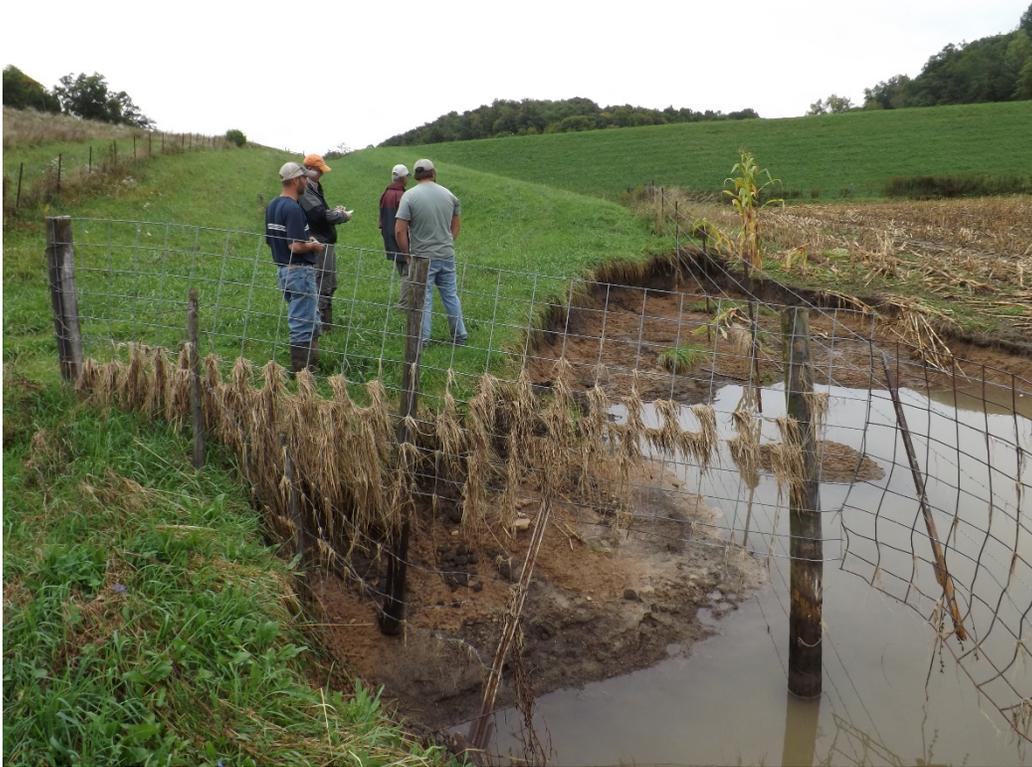
The committee then traveled to WFK 3. While this site was not part of the investigation, it was an opportunity for the committee to see a site that overtopped without breaching. Except for a shallow scour hole at the very end of the auxiliary spillway (see Attachment B, Photo 26 and Photo 27), there was remarkably little damage (see Attachment B, Photo 28). Note that a field fence had been constructed immediately downstream of the end of the auxiliary spillway and that there was a defined drop in elevation from the auxiliary spillway side to the field side of the fence (see Attachment B, Photo 27). This sharp change in gradient appears to be the impetus for developing the scour hole. A much smaller area of scour was noted at the downstream toe of the right groin; a function of the overtopping flow (see Attachment B, Photo 30).

View of scour hole at downstream end of auxiliary spillway from downstream side.  
(WFK 3)

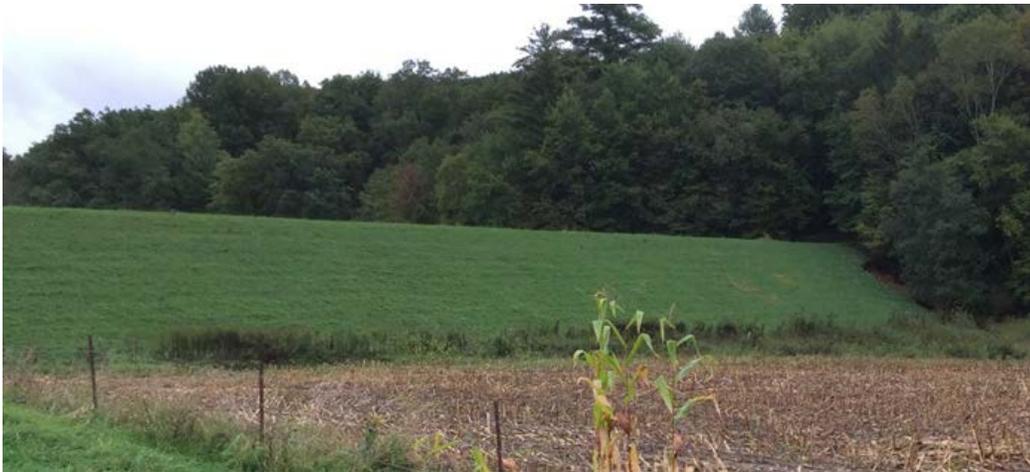
No damage to the downstream side of the embankment was observed. The vegetative cover appeared to be intact showing no sign that vegetative shear stress was exceeded (see Attachment B, Photo 29). The groin on the left end of the embankment, however, was damaged significantly (see Attachment B, Photos 31, 32 and 33). A fence had been constructed down the groin and there is a defined change in vegetative cover with grass on the dam side and timber on the opposite side of the fence. The vegetation evidently failed on the timber side first, on the lower slope of the groin, and then migrated upstream crossing under the fence and onto the dam side of the groin. The as-built plans show that sod was placed in all the groins with a channel shape similar to a parabola (see Attachment C, WFK 3 Sheet 18 of 18). While the right groin has been maintained, the left groin has not. The fence and encroachment of the timber have changed the flow characteristics and erosion resistance of the left groin. This observation holds significant implications for the stability of the vegetation in the groins of all the dams in this area.

Photo 29  
Downstream side of embankment. Vegetative cover did not fail during over-topping.  
(WFK 3)

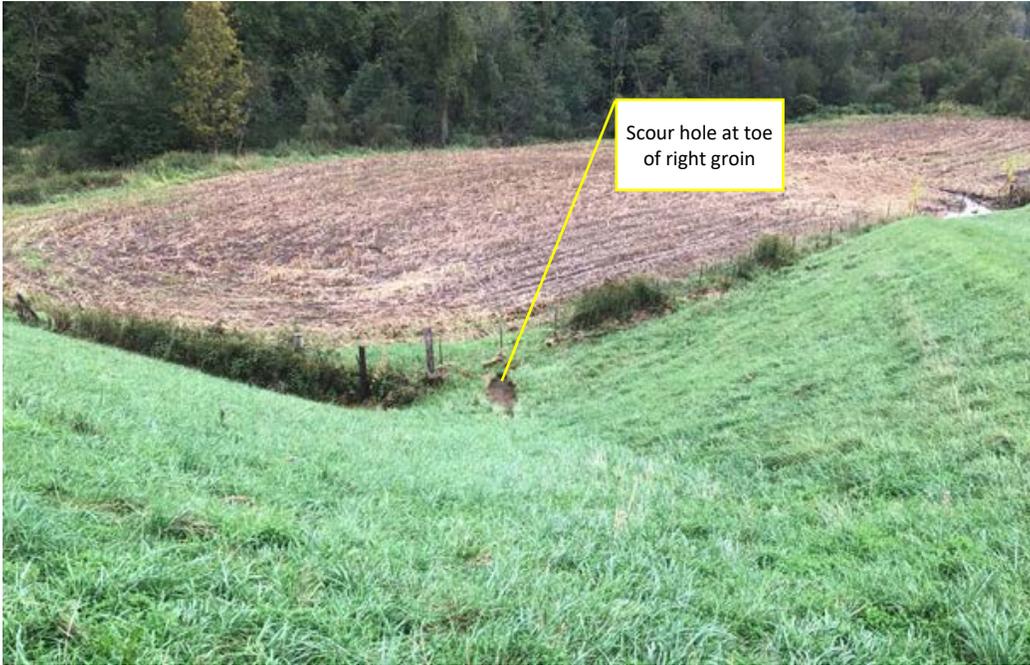
Photo 30  
View of right groin from top of dam.  
(WFK 3)

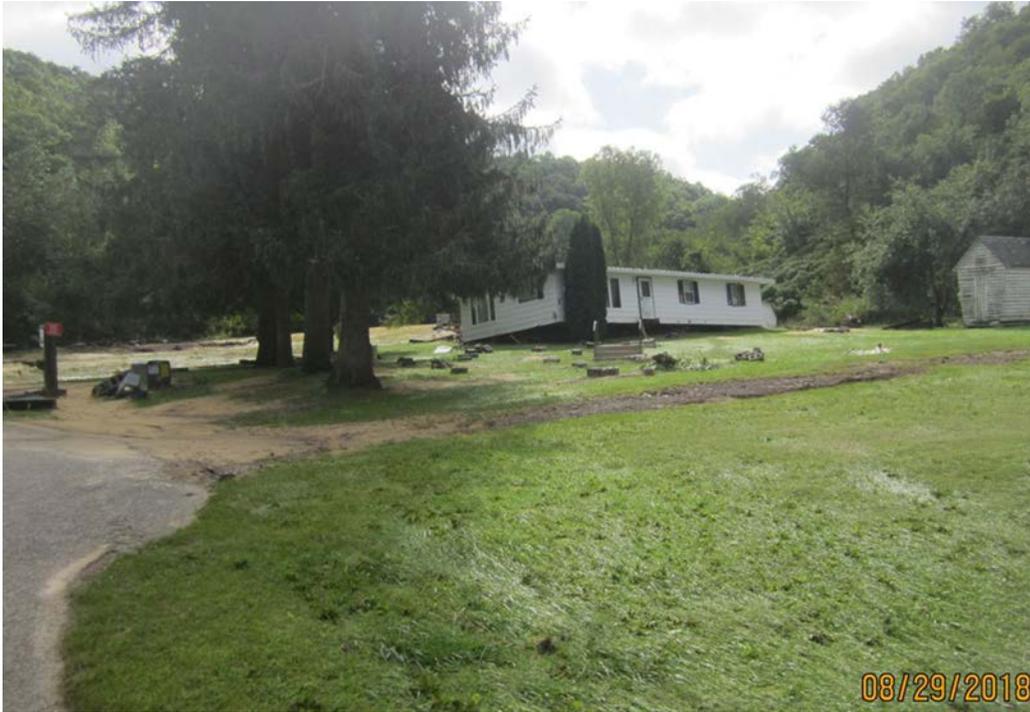
Photo 58  
View from downstream county road of damaged house in breach inundation area.  
(CC 23)

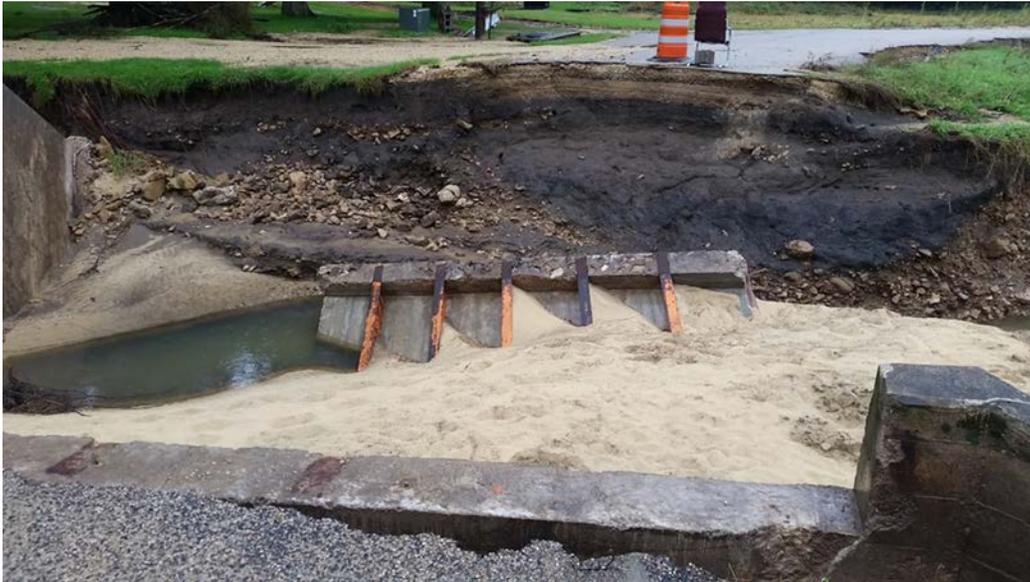
Photo 59  
Remnants of county bridge downstream of house.  
(CC 23)

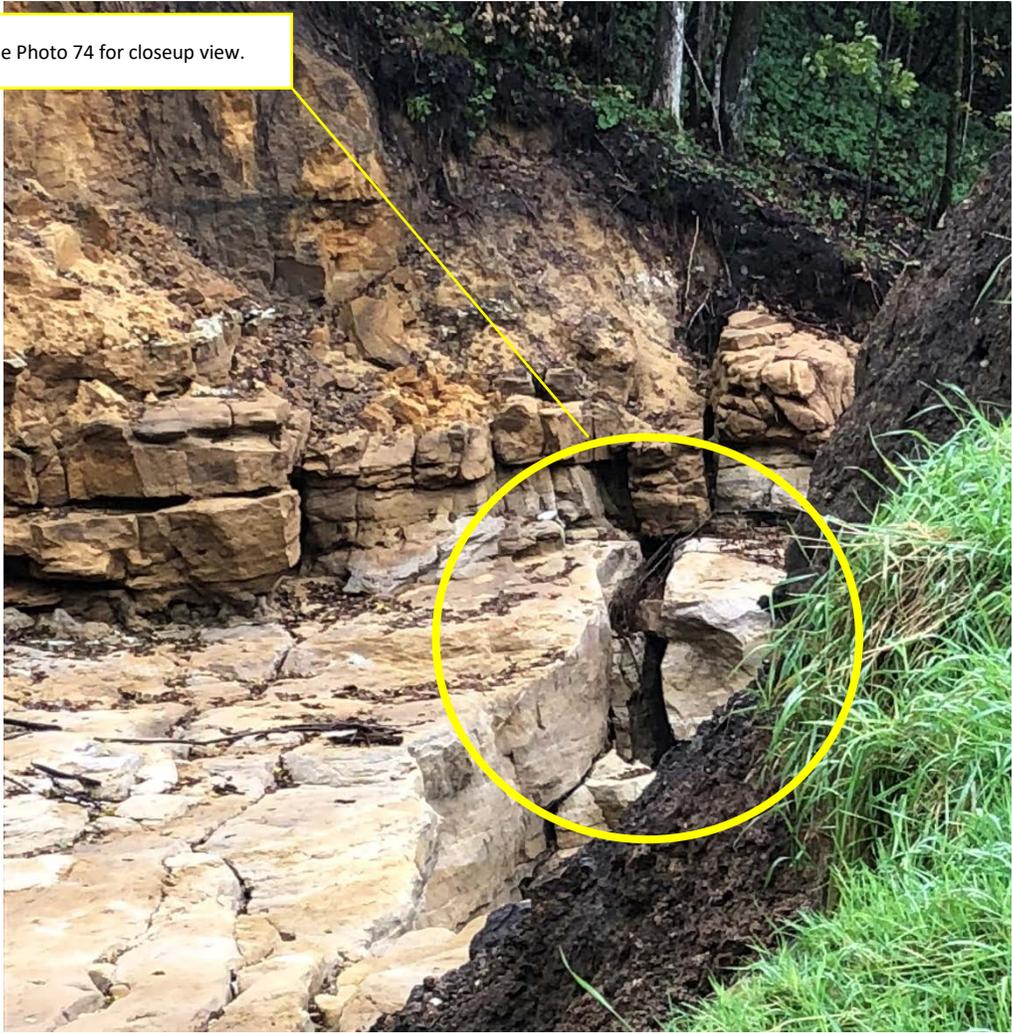
Photo 73

View of vertical valley relief fractures in exposed bedrock of breach channel.  
(CC 23)

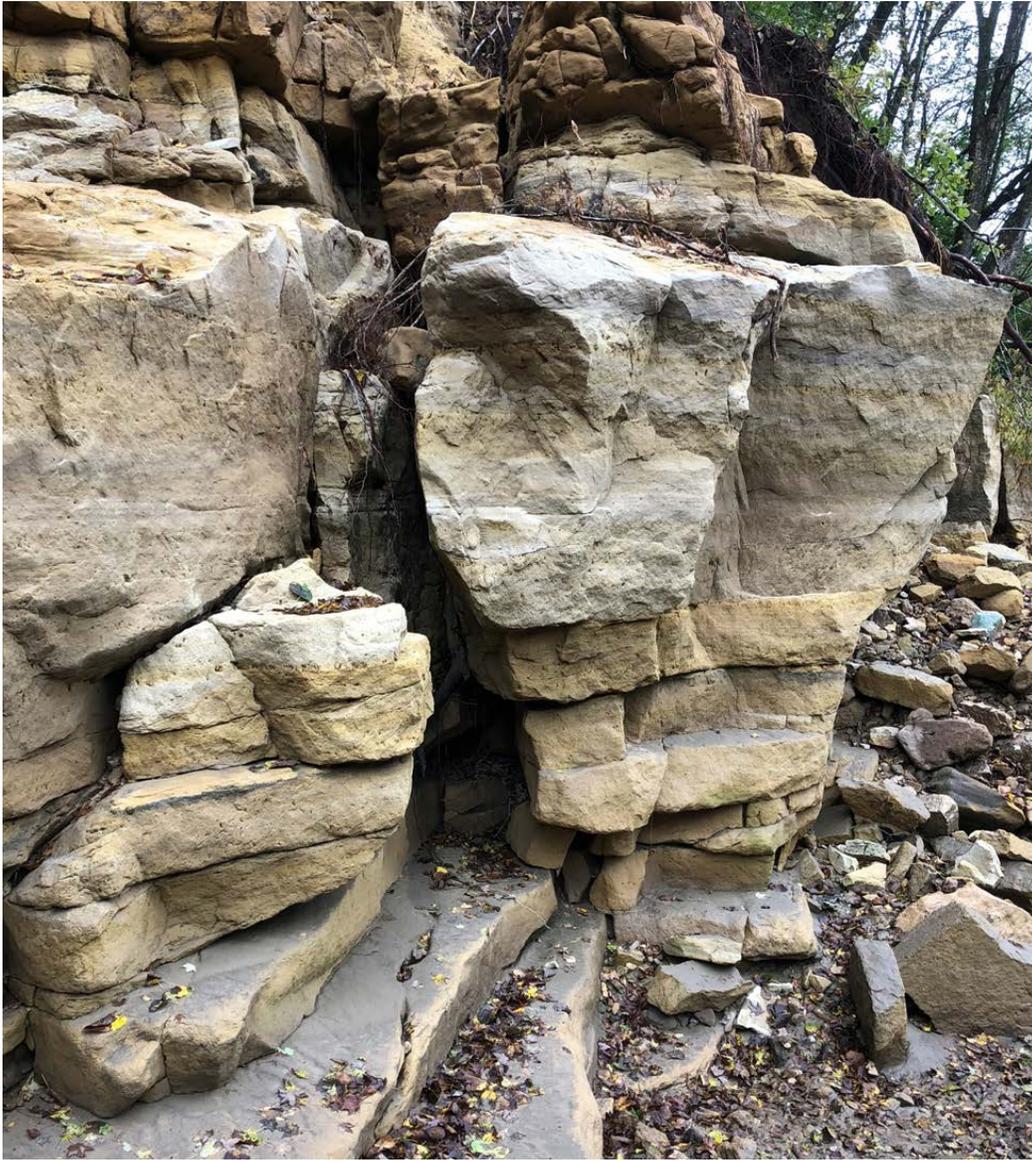
Photo 74  
Close up view of vertical valley relief fracture.  
(CC 23)
