U.S. PUBLIC LAND CORNER MAINTENANCE

Corner ID : S1/4 Sec. 7, T18N-R1E

CERTIFIED LAND CORNER

No. 52

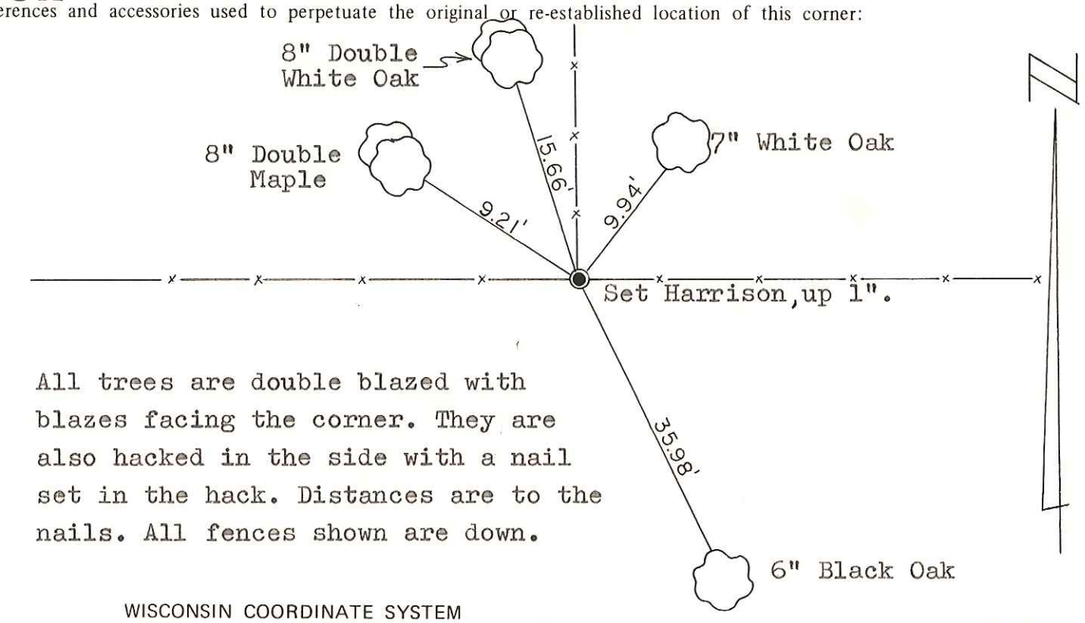
Found a 2¼"x30" iron pipe (well point) and replaced it with a Harrison monument.

All trees are double blazed with blazes facing the corner. They are also hacked in the side with a nail set in the hack. Distances are to the nails. All fences shown are down.
