INVESTIGATION REPORT FOR COON CREEK WATERSHED STRUCTURES 21, 23, AND 29,  
AND WEST FORK KICKAPOO WATERSHED STRUCTURES MLSNA AND 1  
MONROE AND VERNON COUNTIES, WISCONSIN

U.S. DEPARTMENT OF AGRICULTURE  
NATURAL RESOURCES CONSERVATION SERVICE

June 26, 2019

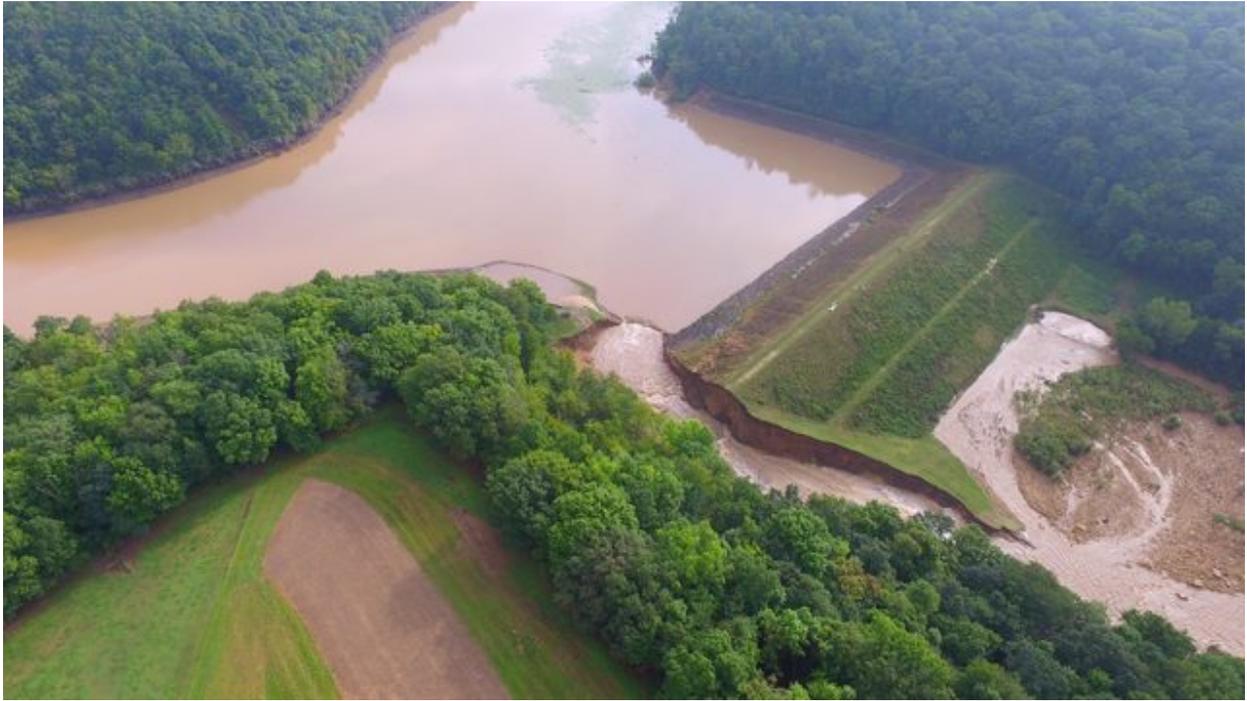
Photo A1  
Aerial View of WFK 1 following breach on August 28, 2018

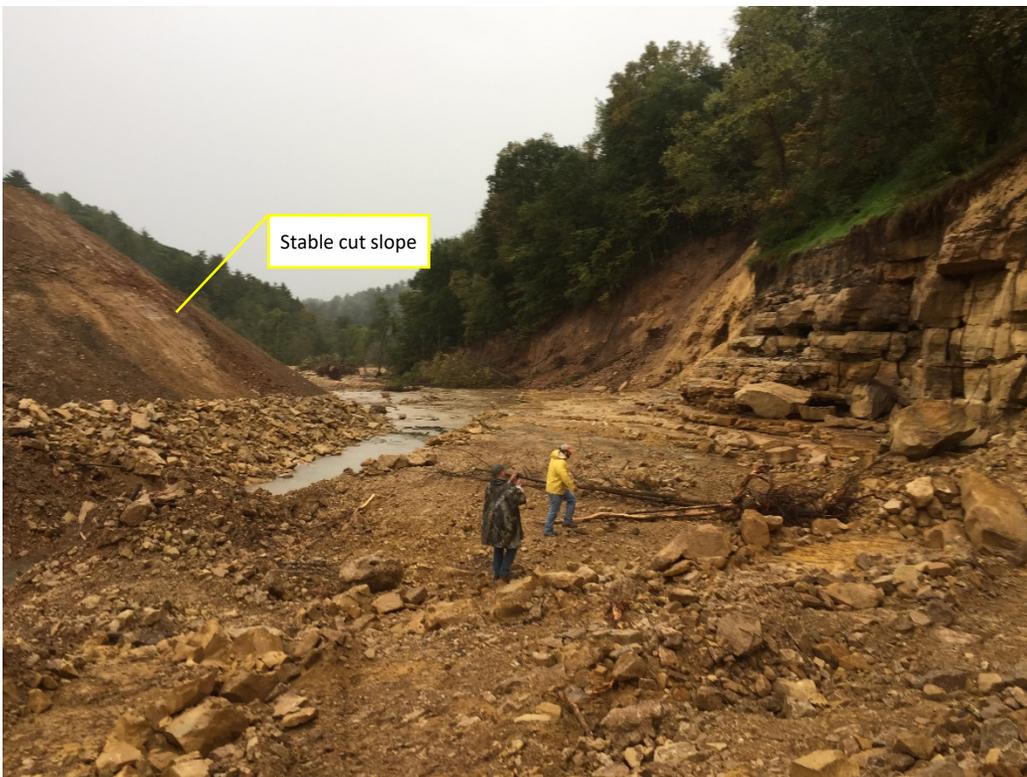
Photo 2  
View of Breach Channel from Upstream  
(WFK 1)

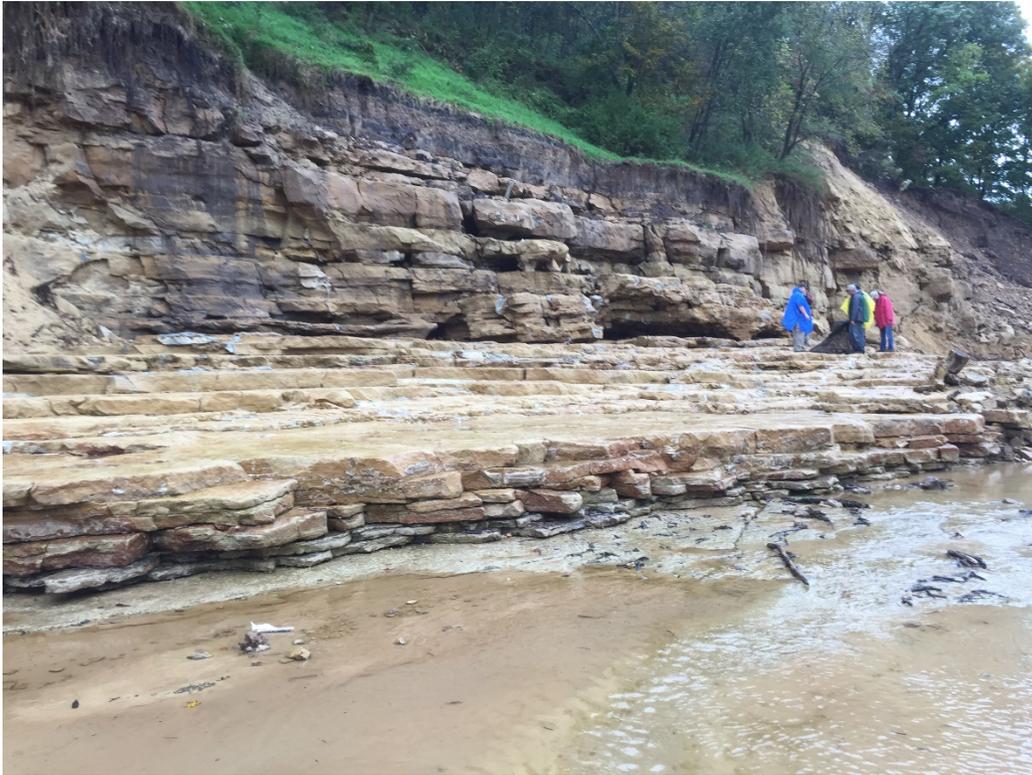
Photo 3  
Exposed right abutment showing jointed bedrock  
(WFK 1)

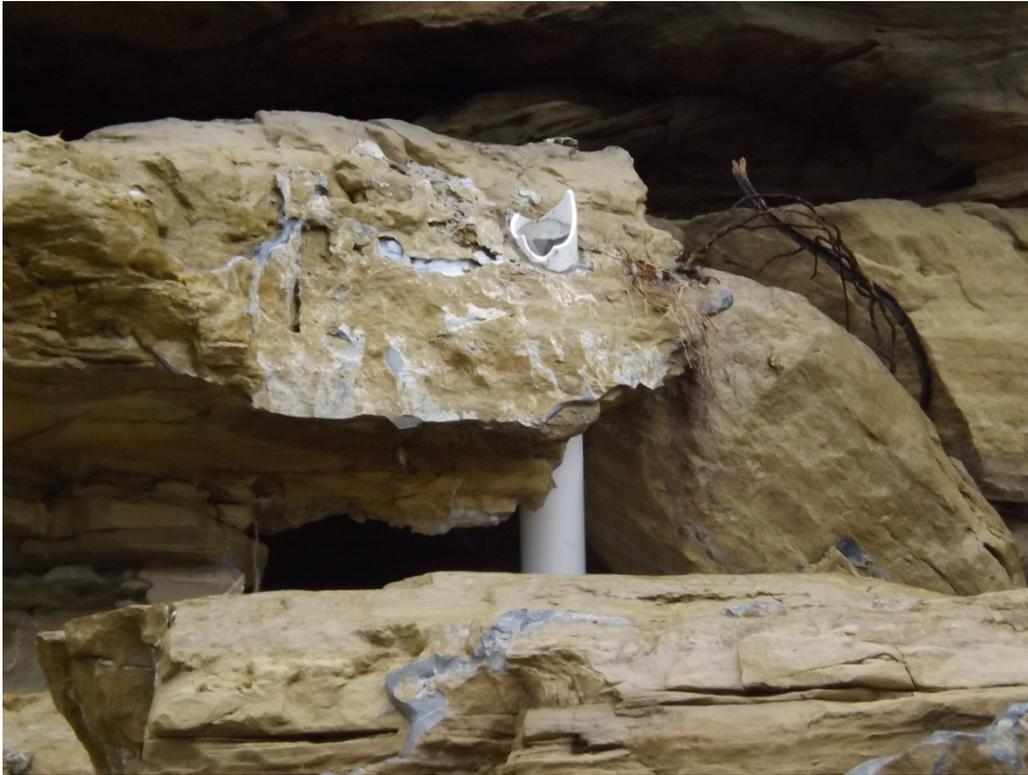
Photo 6

PVC and grout from 2009/2010 pressure grouting – right abutment near centerline dam. Note large voids in bedrock left by eroded sandstone.

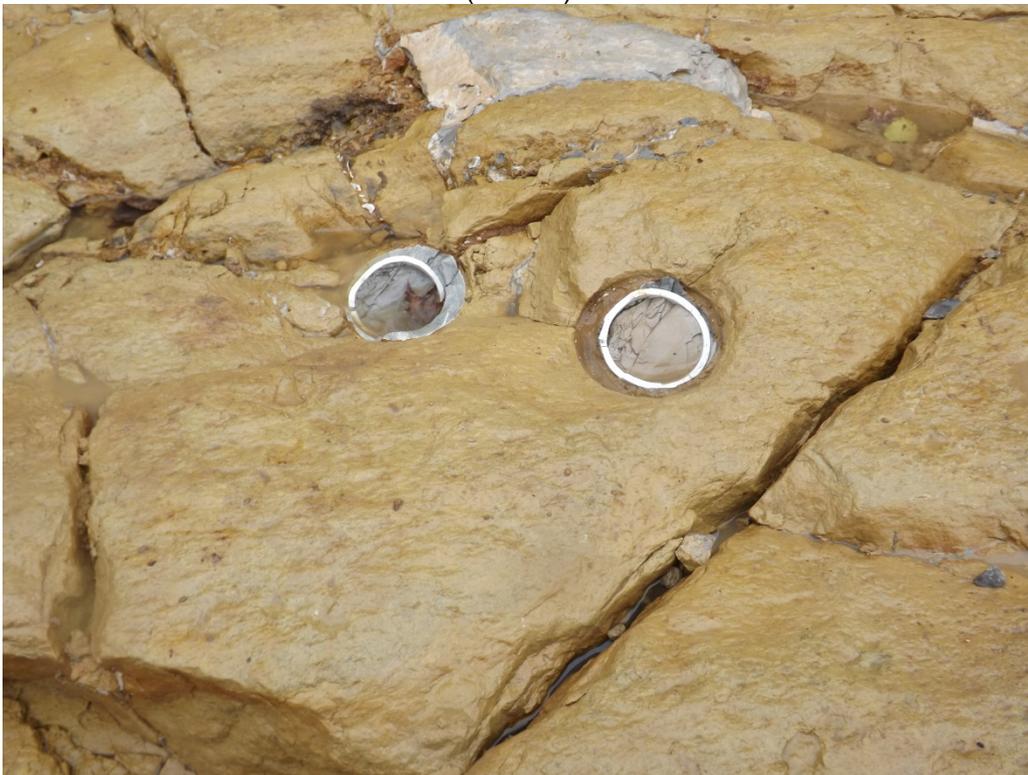
Photo 7

Remnant PVC and grout from 2009/2010 pressure grouting.

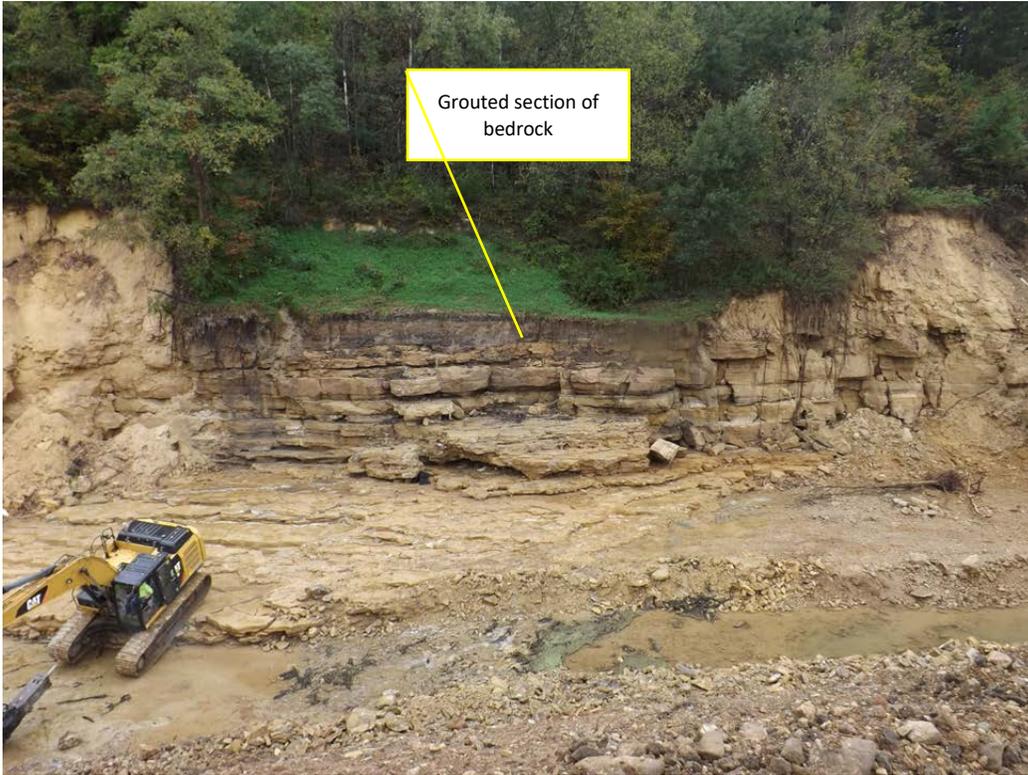
Photo 8

Breach channel from centerline top of dam. Note difference in stability of bedrock in curtain wall versus bedrock upstream and downstream.  
(WFK 1)

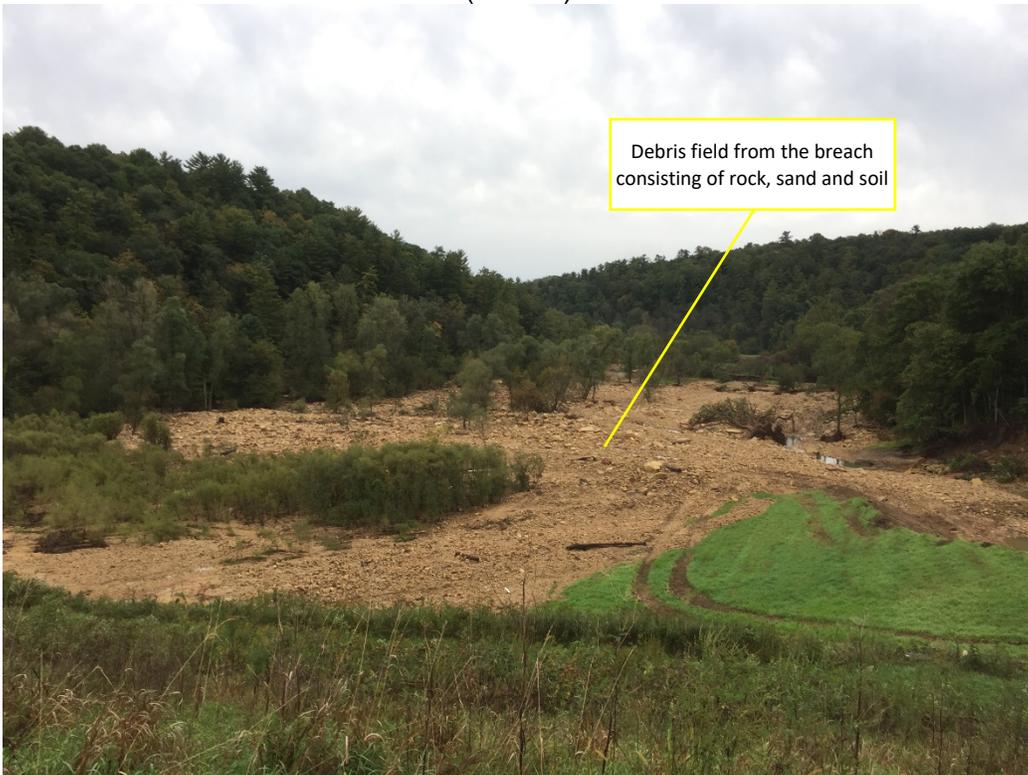
Photo 9

View of downstream breach inundation area from top of dam.  
(WFK 1)

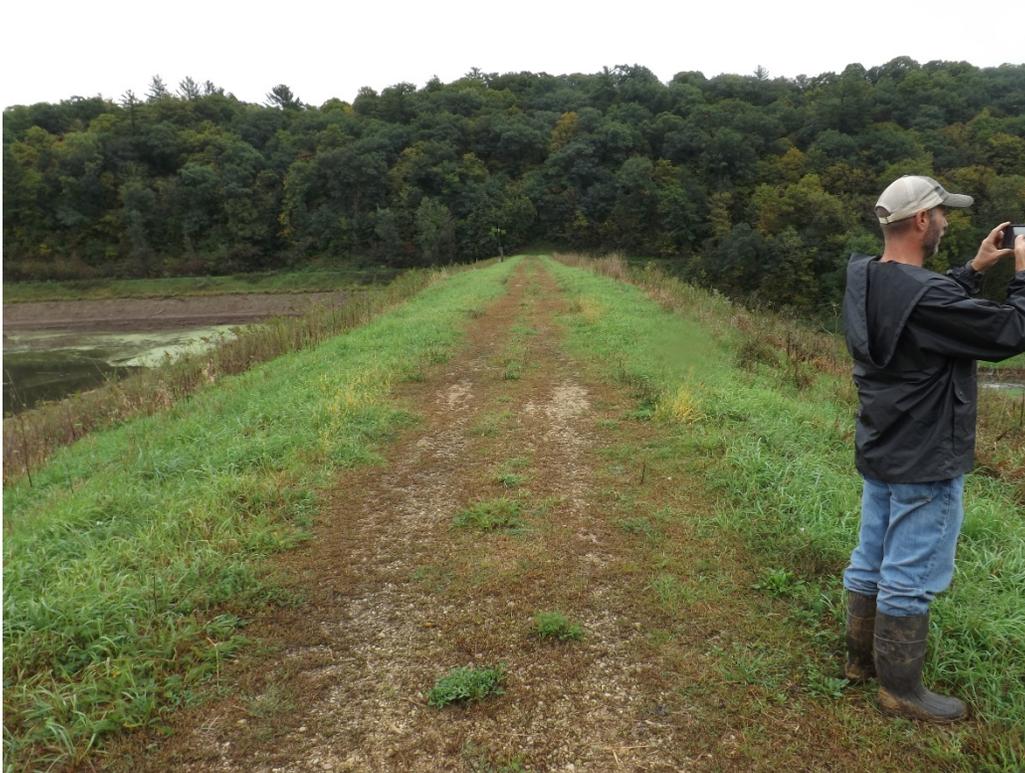
Photo 10  
View of top of dam from right end near top of cut slope.  
(WFK 1)

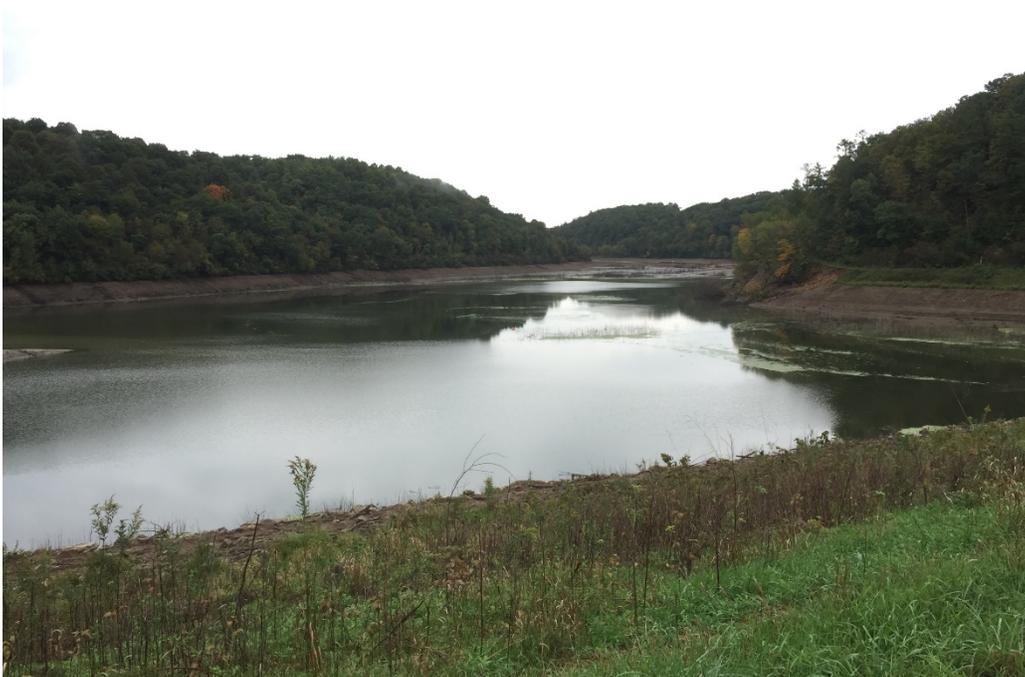
Photo 11  
View of upstream pool from beach area.  
(WFK 1)

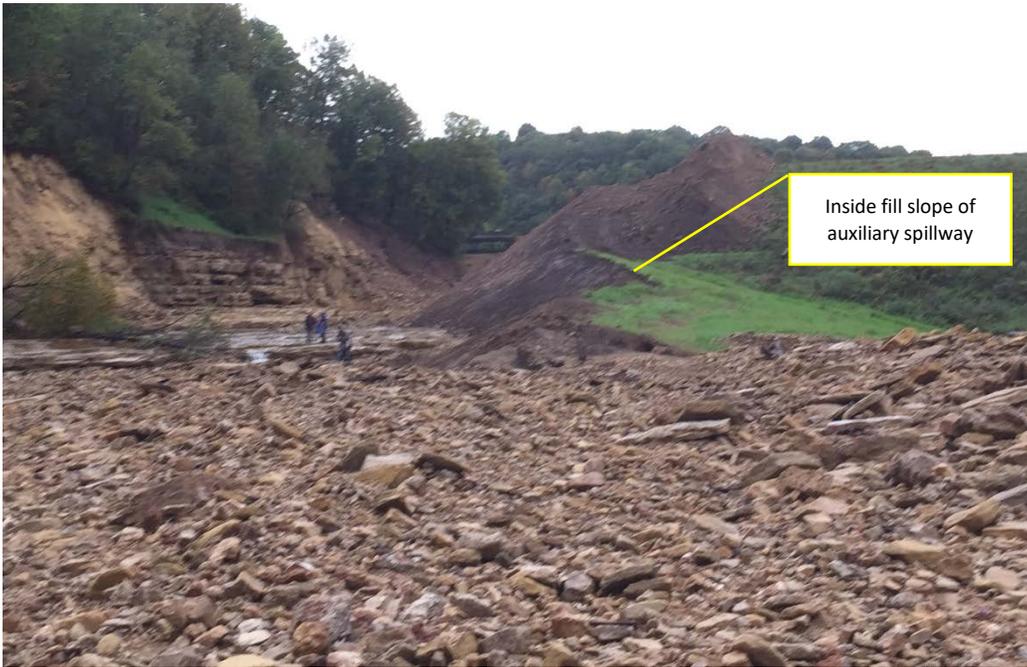
Photo 12  
View of breach channel and left end of dam from downstream of dam.  
(WFK 1)

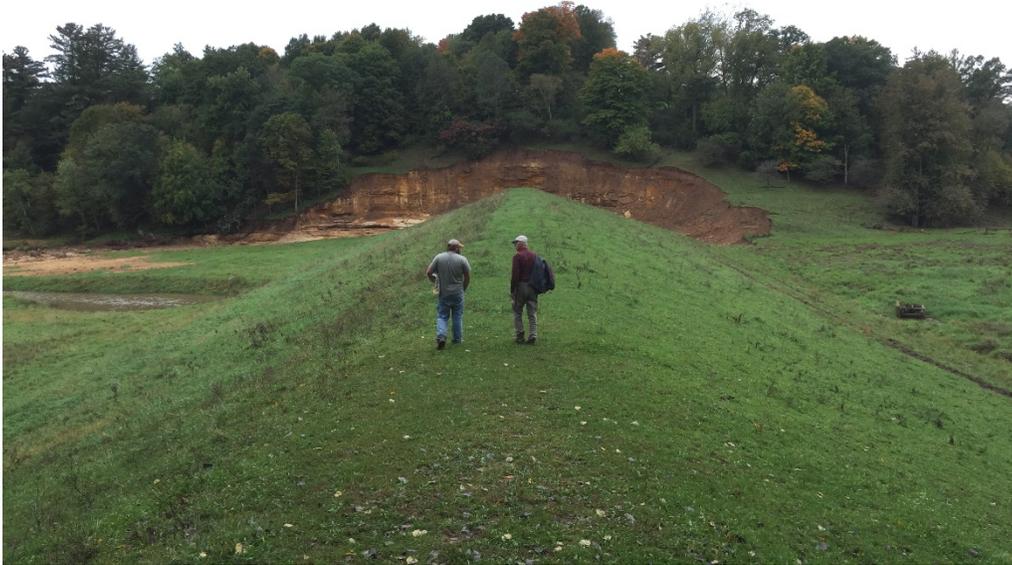
Photo 14

View of the embankment from the left end of dam with breach in background.  
Note short vegetation due to grazing.  
(WFK MLSNA)

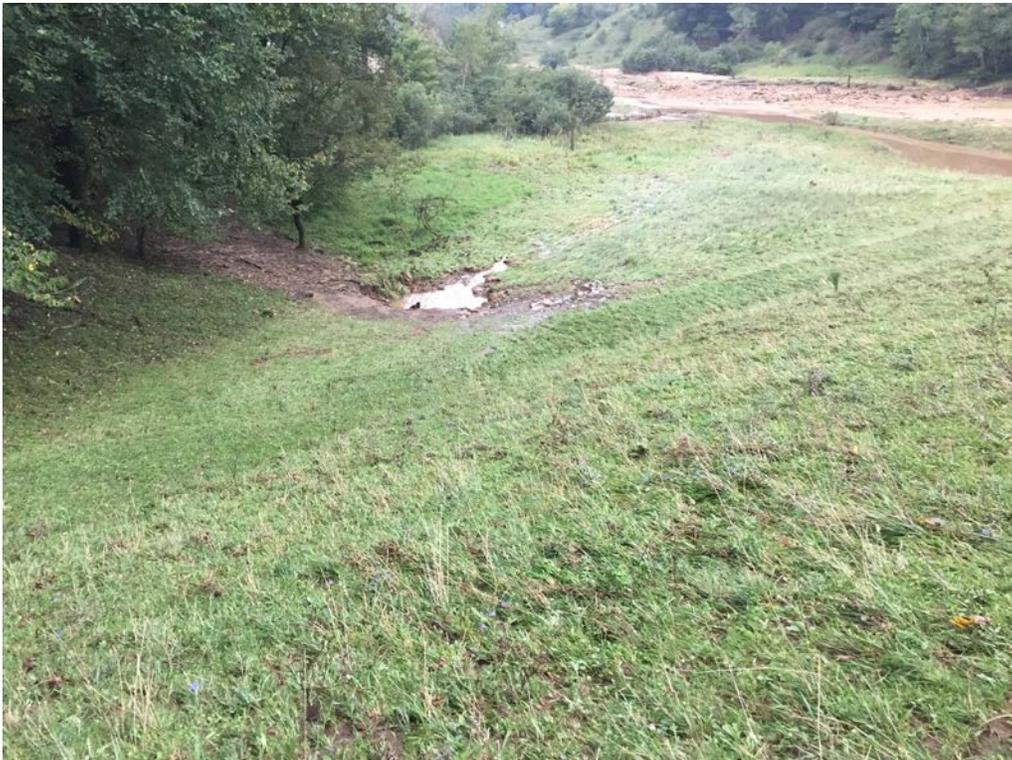
Photo 15

There was overtopping flow at this site, but outside of the breach there was no significant damage to the embankment. A scour hole did develop at the downstream toe of the left groin and some of the vegetation was starting to erode from the lower slope of the groin. The scour hole was about three feet deep and had eroded into bedrock (see Attachment B, Photos 15 and 16).

View of scour hole at the toe of the left downstream groin from the top of dam.  
(WFK MLSNA)

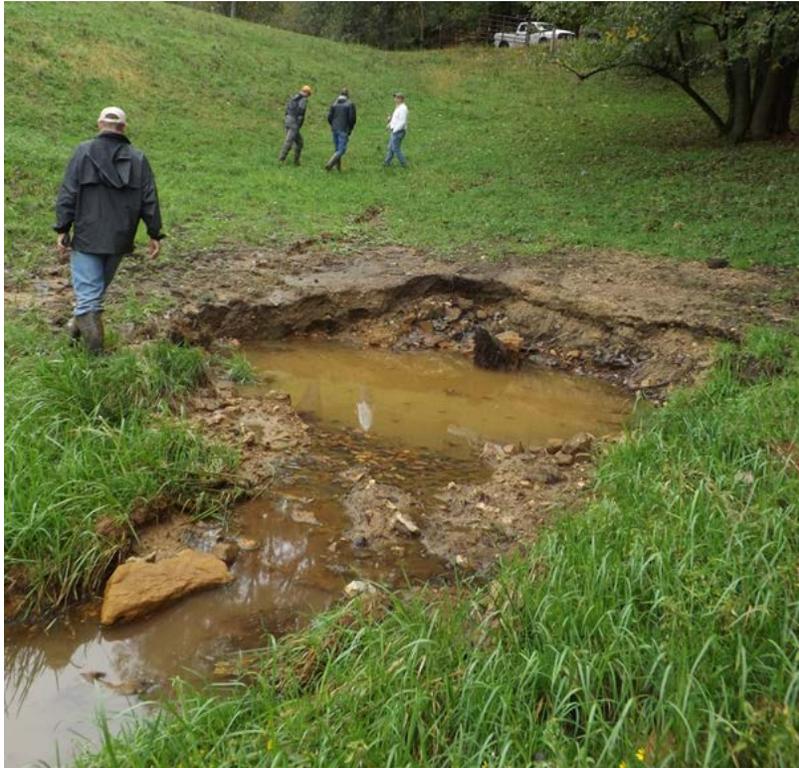
Photo 16  
Scour hole at toe of left downstream groin.  
(WFK MLSNA)

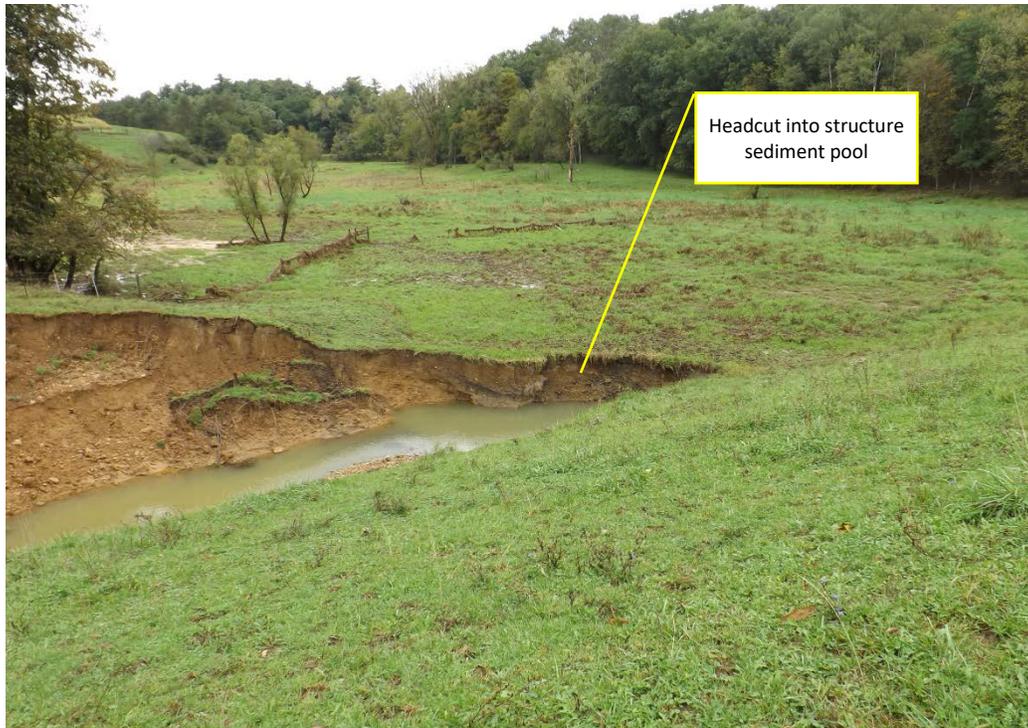
Photo 17  
View of breach channel and upstream headcut from breach channel near centerline of dam.  
(WFK MLSNA)

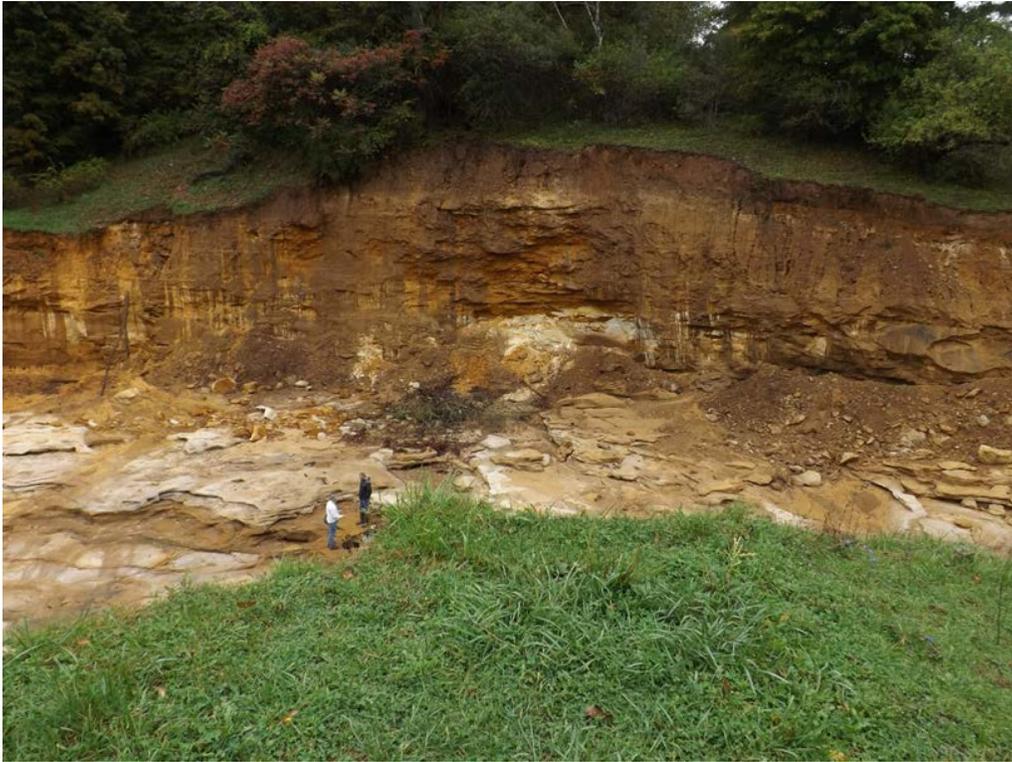
Photo 18

View of exposed bedrock in breach channel (right abutment) from top of dam.  
(WFK MLSNA)

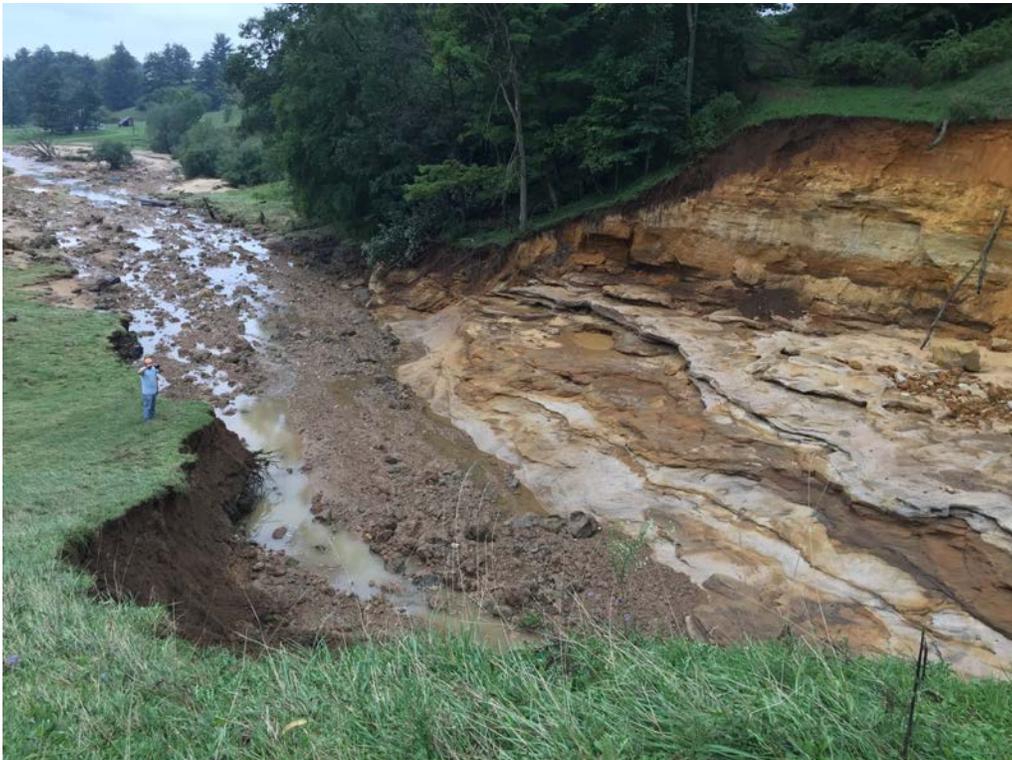
Photo 19

View of downstream section of breach channel showing right abutment bedrock from top of  
dam.  
(WFK MLSNA)

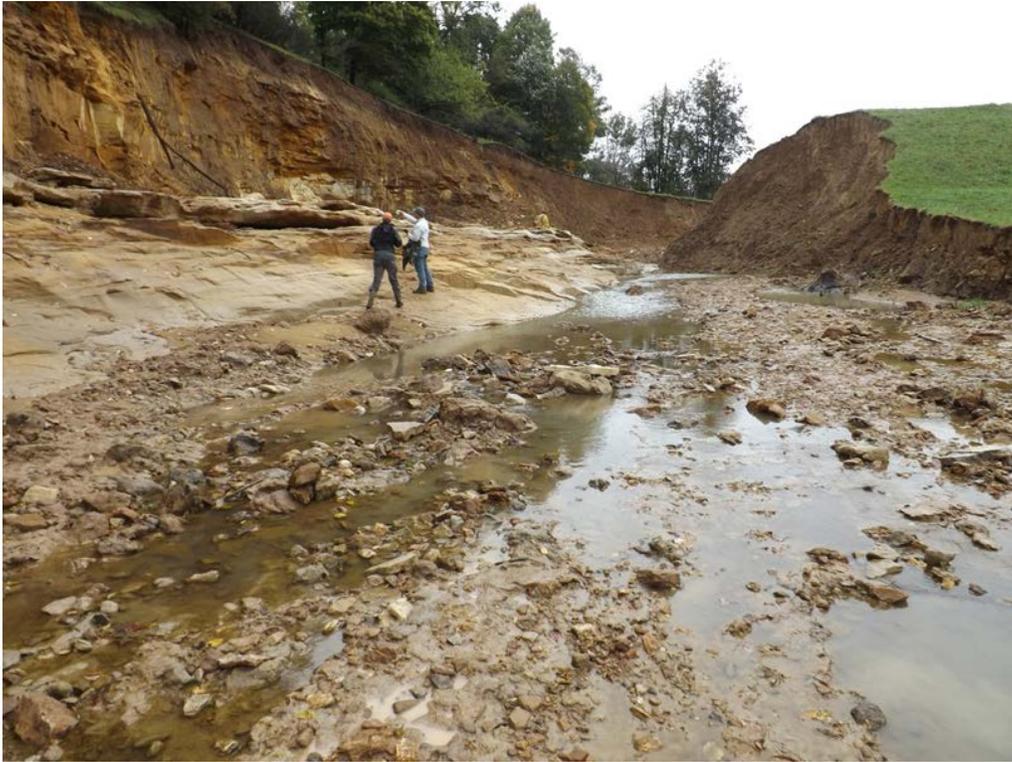
Photo 20

View looking upstream of exposed bedrock in the breach channel (right abutment) from the downstream end of the breach channel.  
(WFK MLSNA)

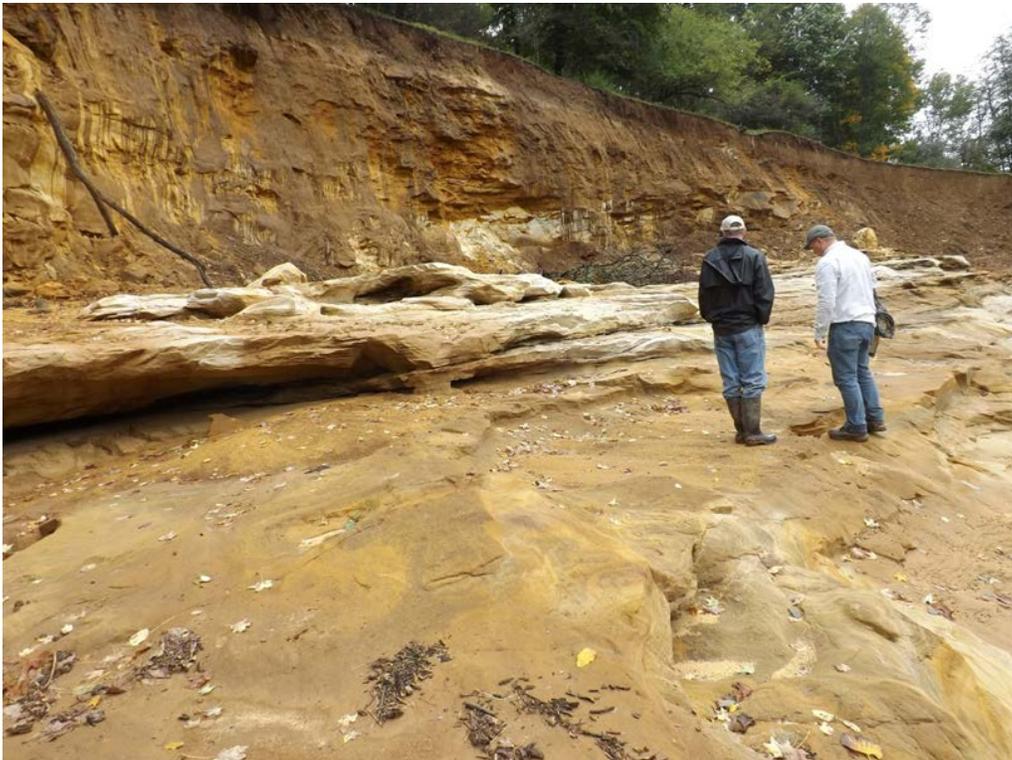
Photo 21

Close up of bedrock in breach channel.  
(WFK MLSNA)

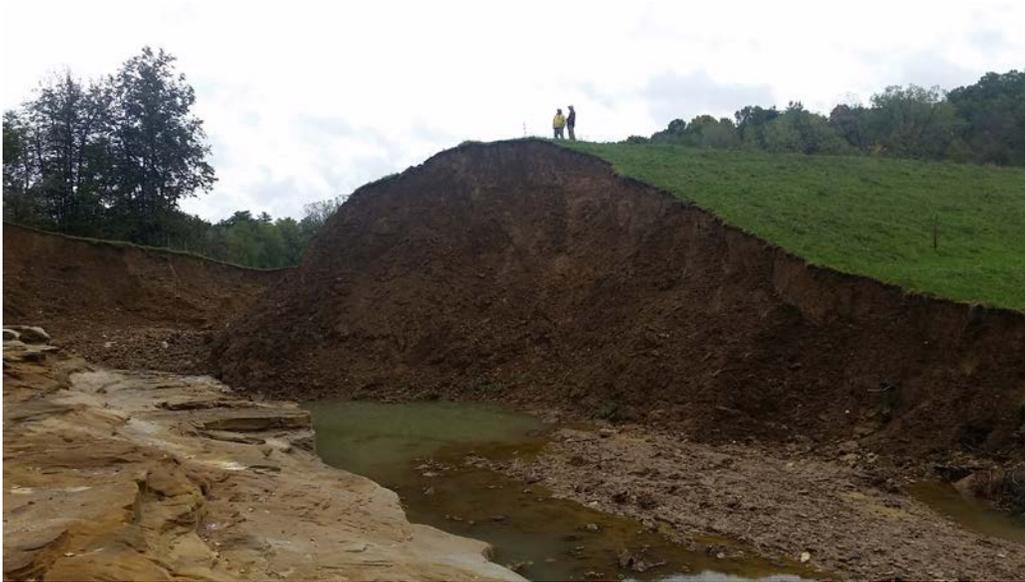
Photo 22

View of right end of dam in breach channel from the downstream end of the breach channel.  
(WFK MLSNA)

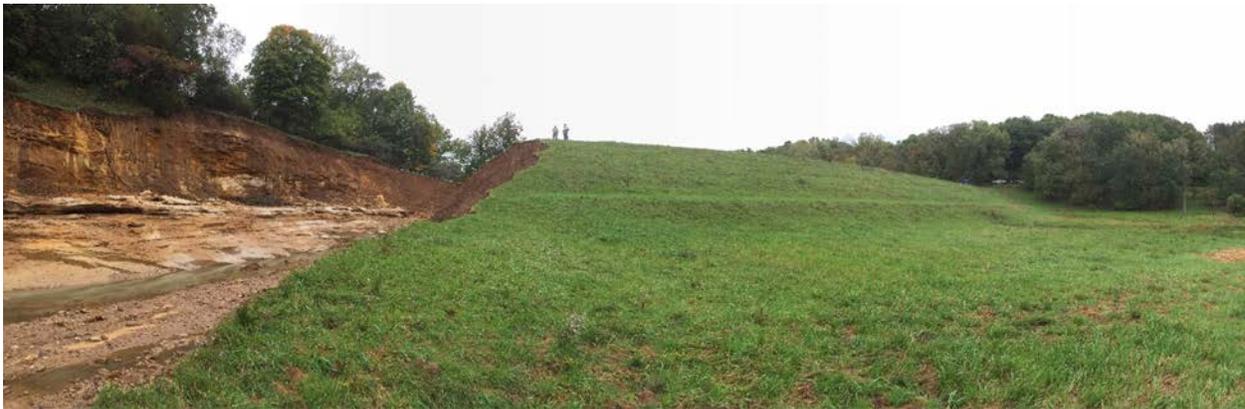
Photo 23

View of dam from abutment to abutment from downstream of dam.  
(WFK MLSNA)

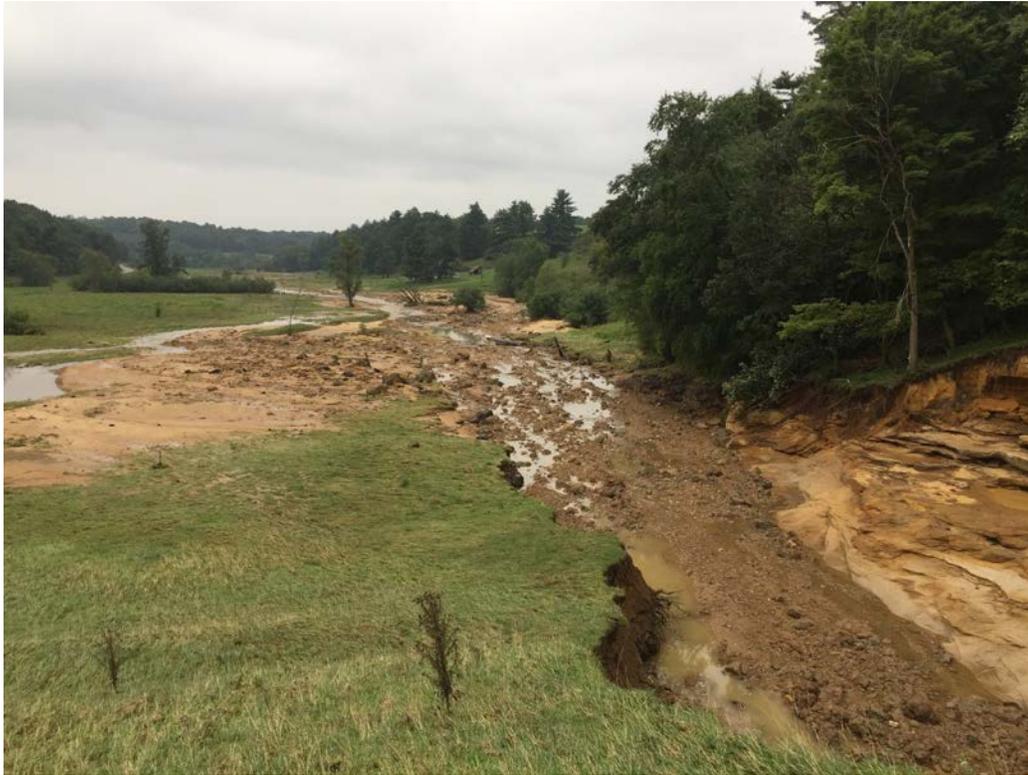
Photo 24  
View of breach inundation area from top of dam.  
(WFK MLSNA)

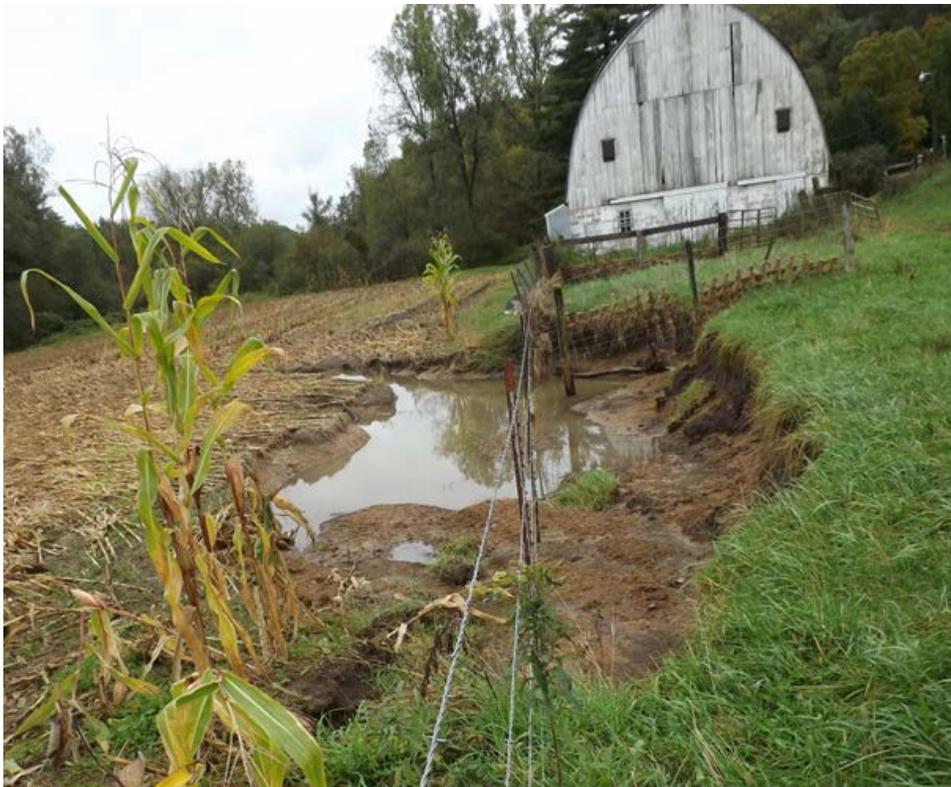
Photo 27

View of scour hole at downstream end of auxiliary spillway from upstream side.  
(WFK 3)

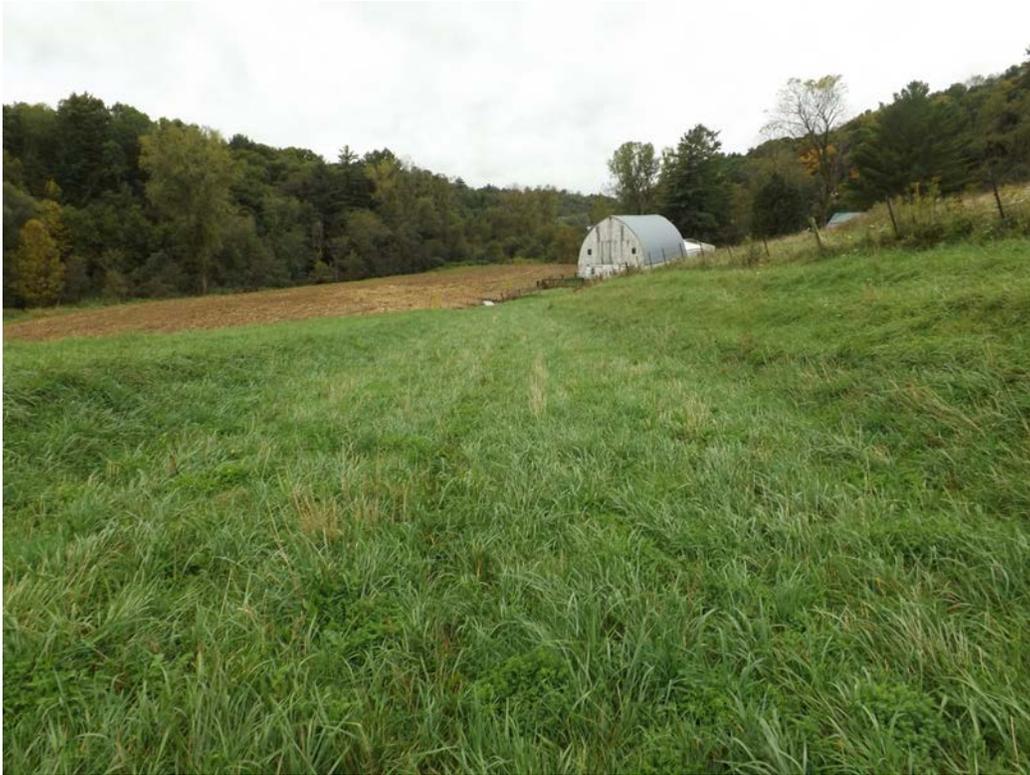
Photo 28  
Exit channel of auxiliary spillway.  
(WFK 3)

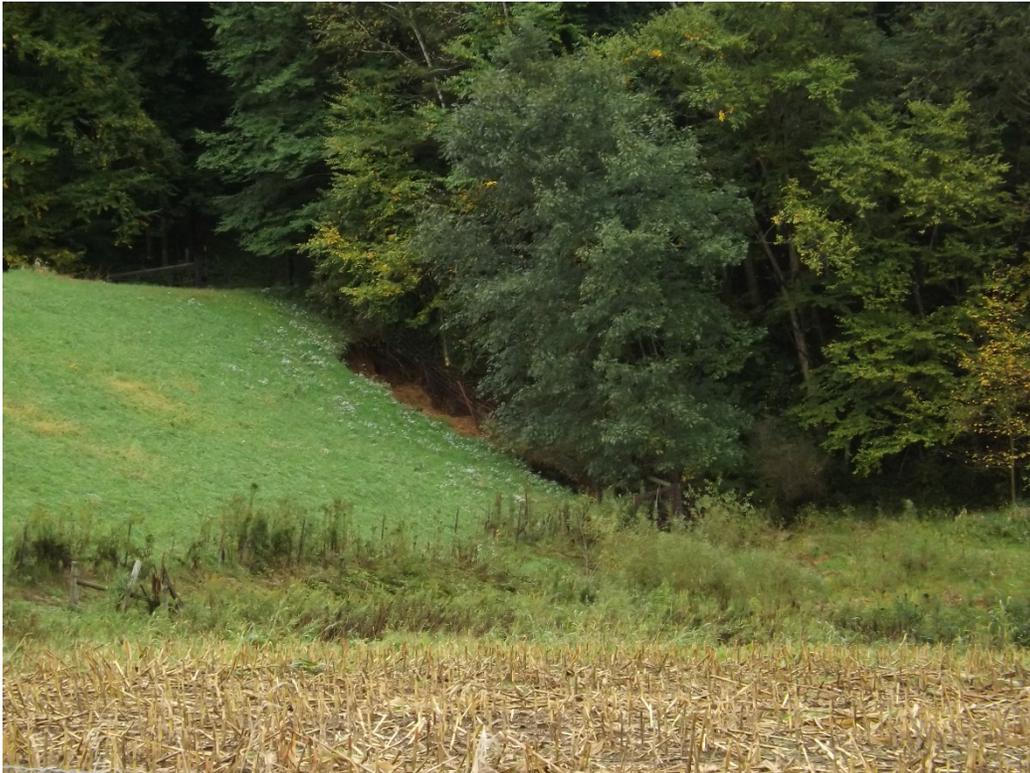
Photo 31  
Erosion in left groin.  
(WFK 3)

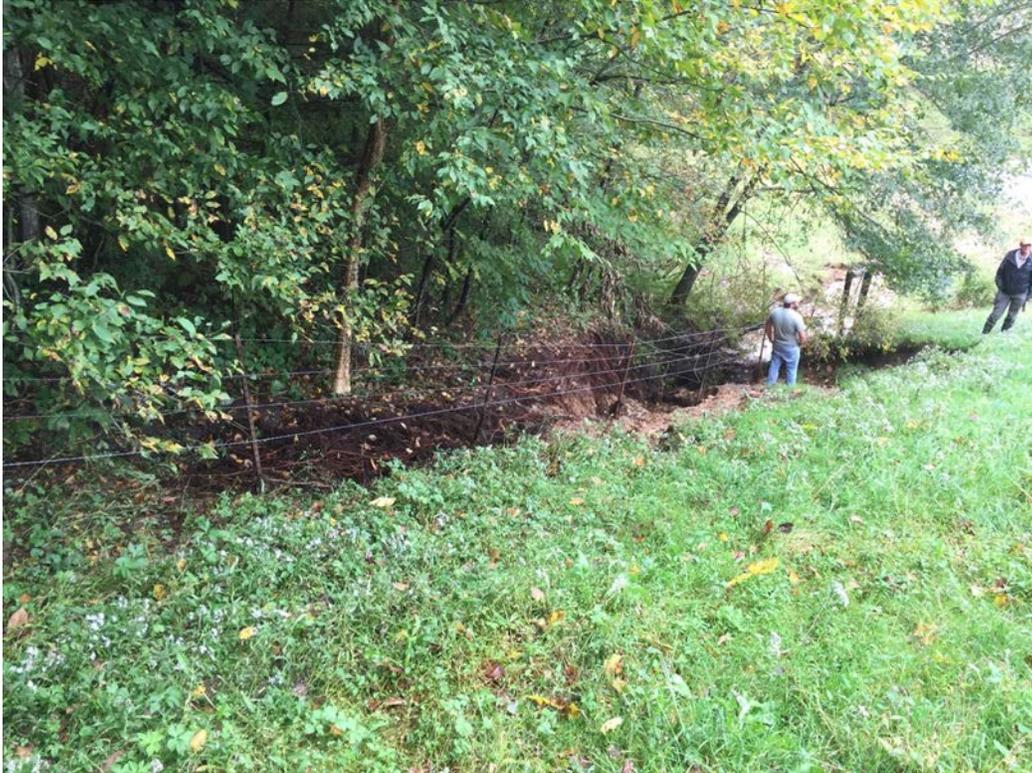
Photo 32  
View of erosion in left groin from top of dam.  
(WFK 3)

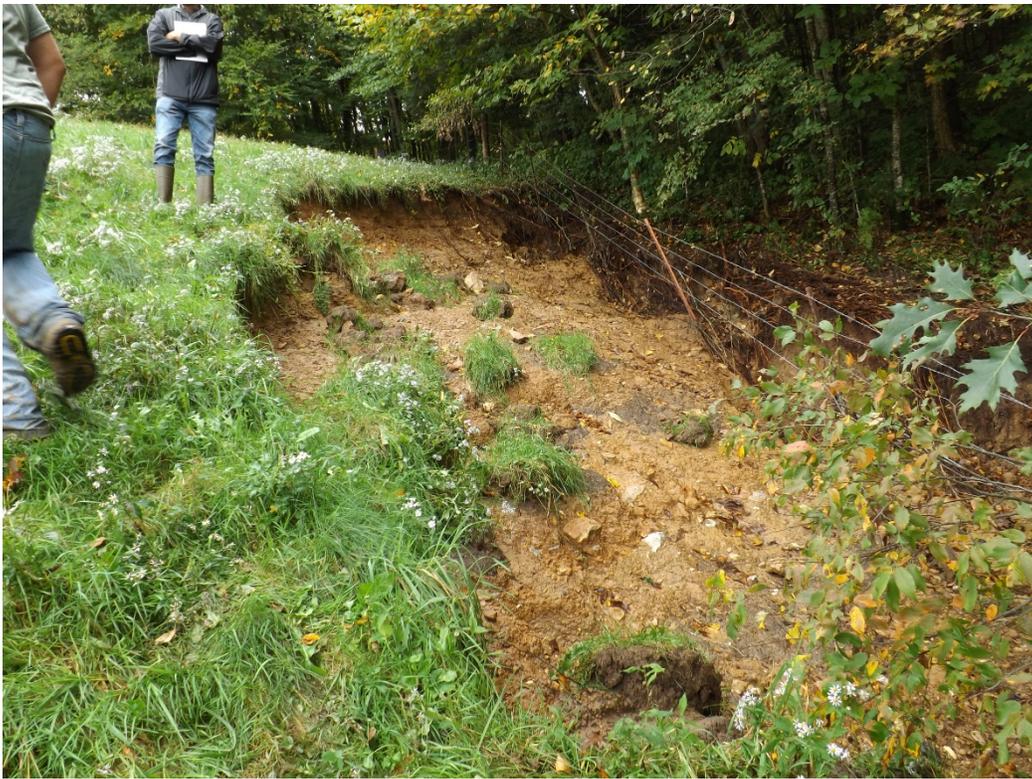
Photo 33  
Erosion in left groin.  
(WFK 3)

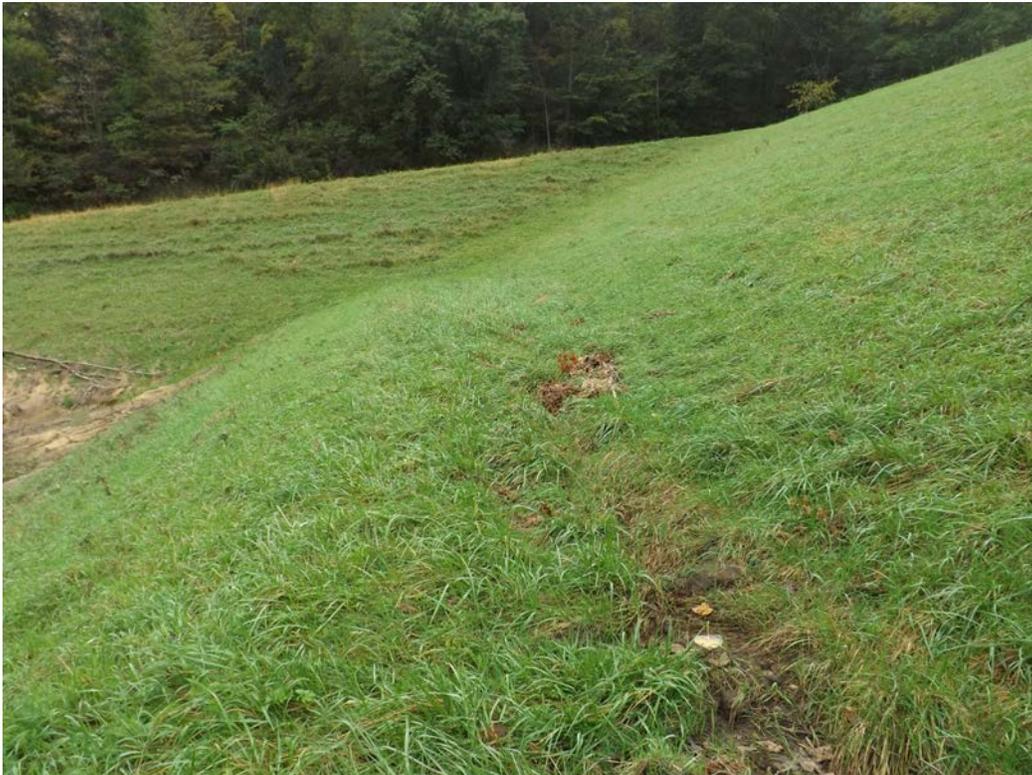
Photo 35  
View of vegetation on downstream berm and embankment.  
(CC 21)

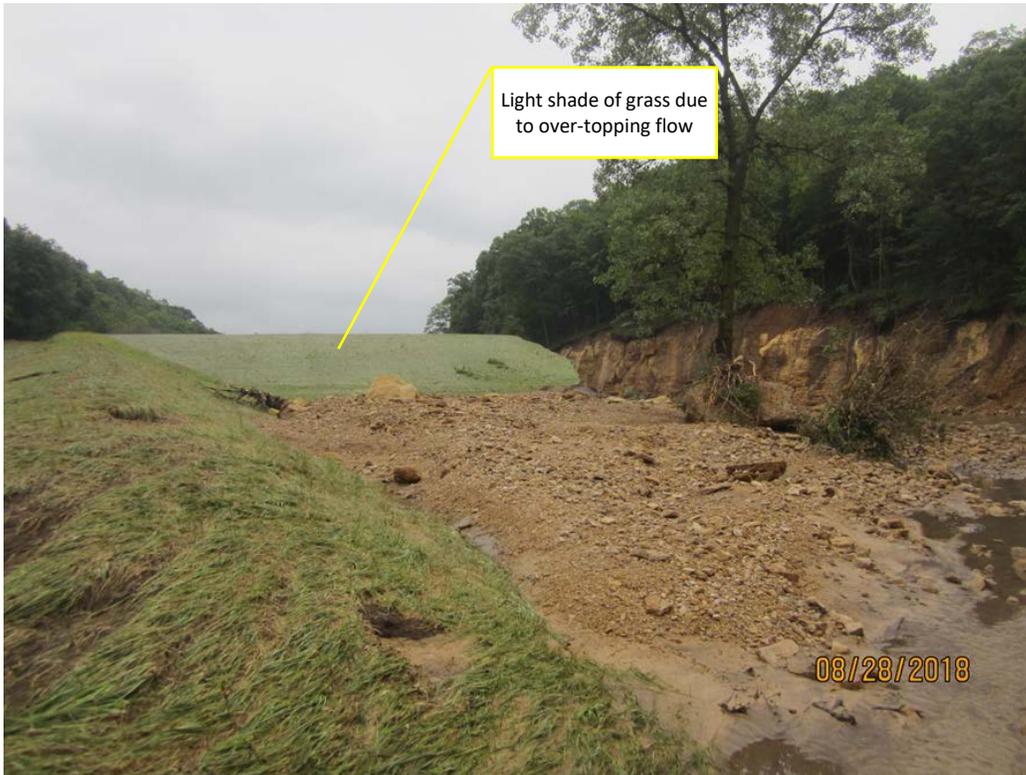
Photo 36  
View of dam, auxiliary spillway and debris field from downstream end of auxiliary spillway.  
(CC 21)

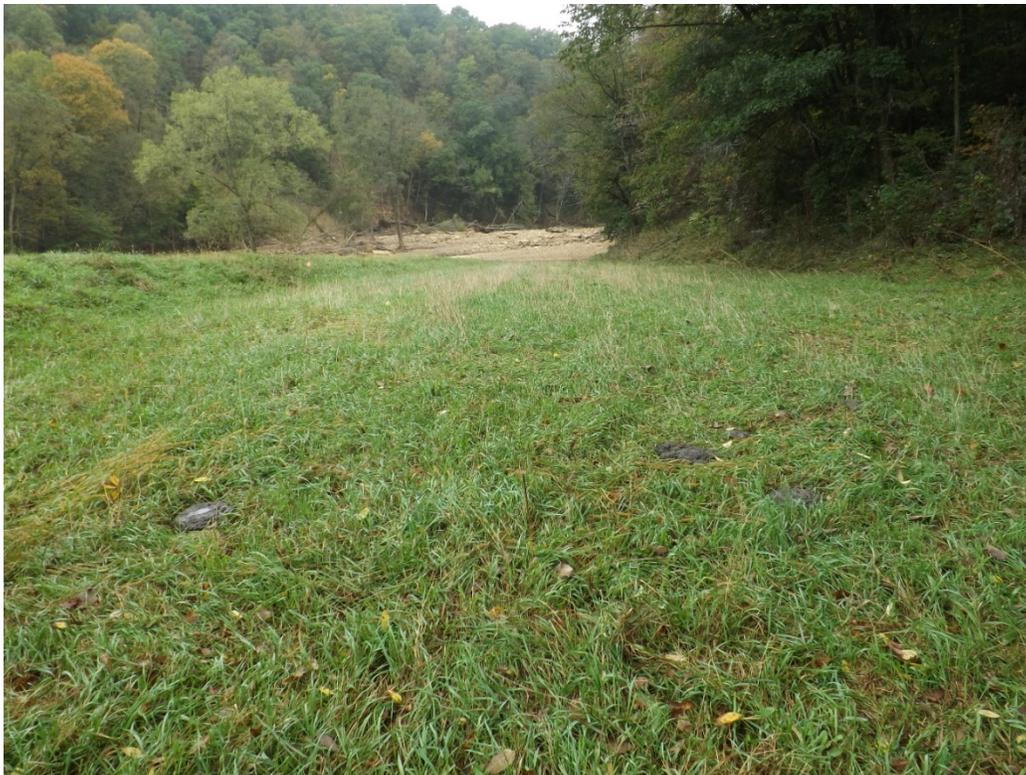
Photo 37  
View of auxiliary spillway exit channel from level section  
(CC 21)
