INVESTIGATION REPORT FOR COON CREEK WATERSHED STRUCTURES 21, 23, AND 29,  
AND WEST FORK KICKAPOO WATERSHED STRUCTURES MLSNA AND 1  
MONROE AND VERNON COUNTIES, WISCONSIN

U.S. DEPARTMENT OF AGRICULTURE  
NATURAL RESOURCES CONSERVATION SERVICE

June 26, 2019

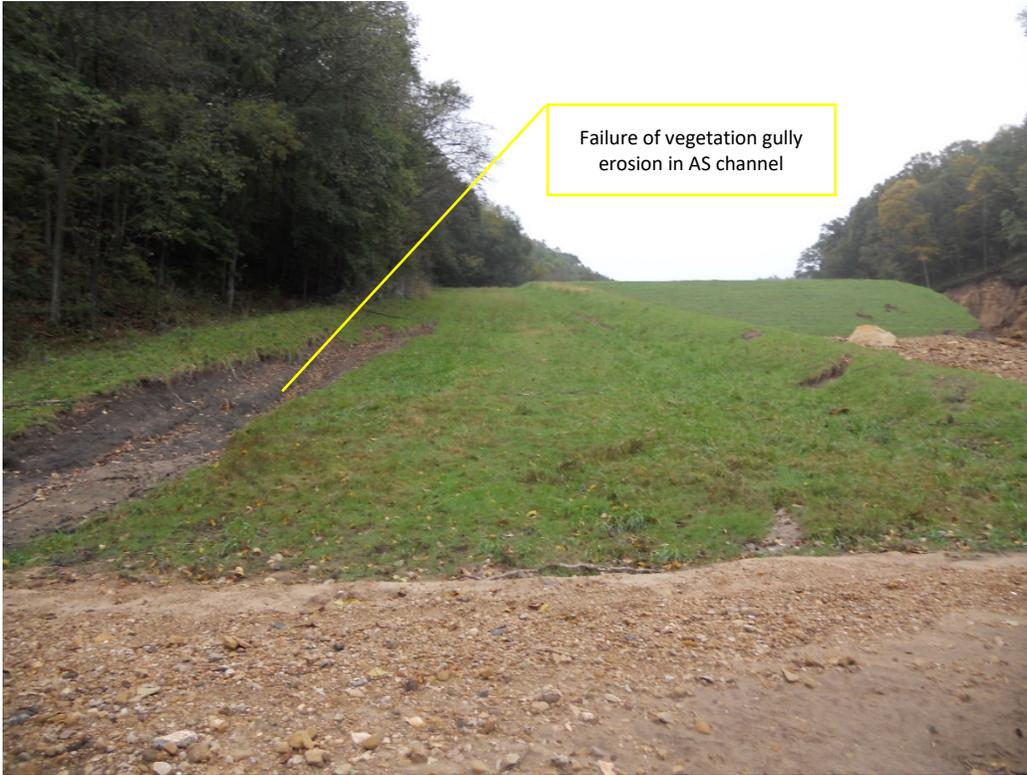
Photo 38

View of auxiliary spillway exit channel from downstream end of auxiliary spillway.  
(CC 21)

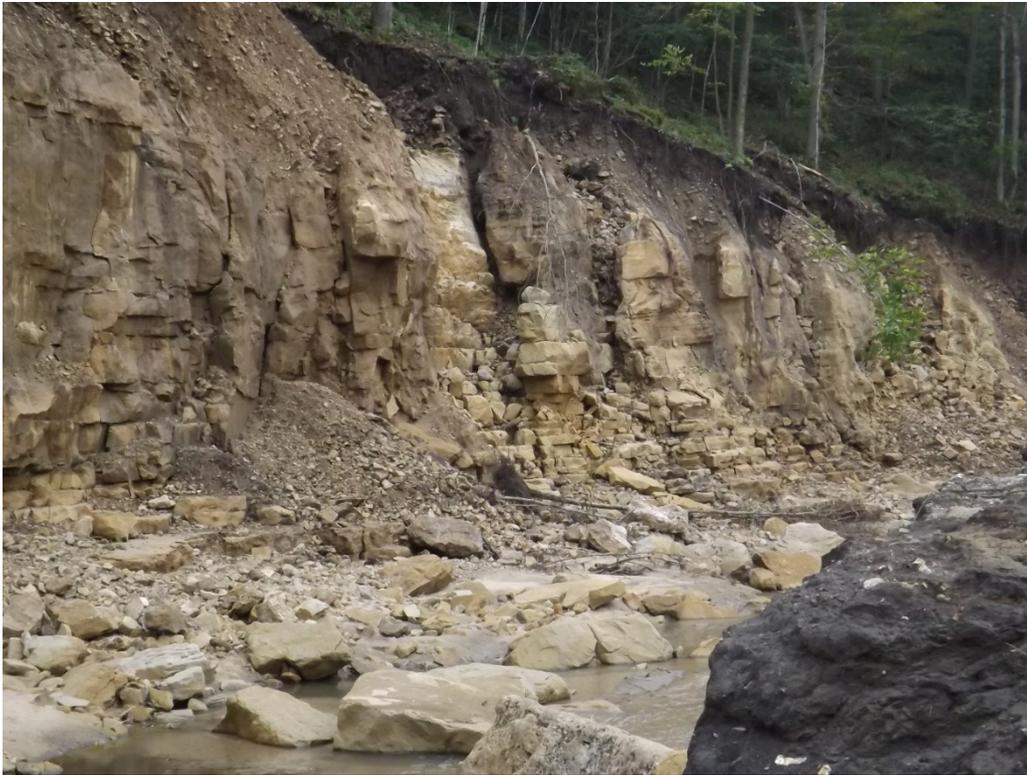
Photo 39

The breach at this site occurred at the left end of the dam. The as-built plans show the dam was constructed with a crown of 0.9 ft. The LiDAR data confirms that there was little settlement as the crown did not settle to the design settled top of dam (see Attachment E, Sheet 13). Therefore, the dam overtopped at the left end before the center of the embankment. Comparing the plan view of combined LiDAR and post-breach contours, it is evident that the breach eroded down through embankment material and then straight into bedrock (see Attachment E, Sheet 12, Plan View, and Sheet 13, Cross Section). After eroding through bedrock under the left end of the embankment, the breach then eroded left into the abutment bedrock (see Attachment B, Photo 34). However, the breach did not move laterally into the deepest part of the embankment, where the principal spillway is located. The erodible nature of the underlying non-cohesive material, and the seepage forces within the valley relief fractures of the bedrock provided less resistance to erosion than the cohesive surface material in the embankment (see Attachment B, Photos 39 and 40). The detailed failure mechanisms are covered in detail in the Geology section.

View of exposed bedrock in breach channel from near upstream toe of dam.  
(CC 21)

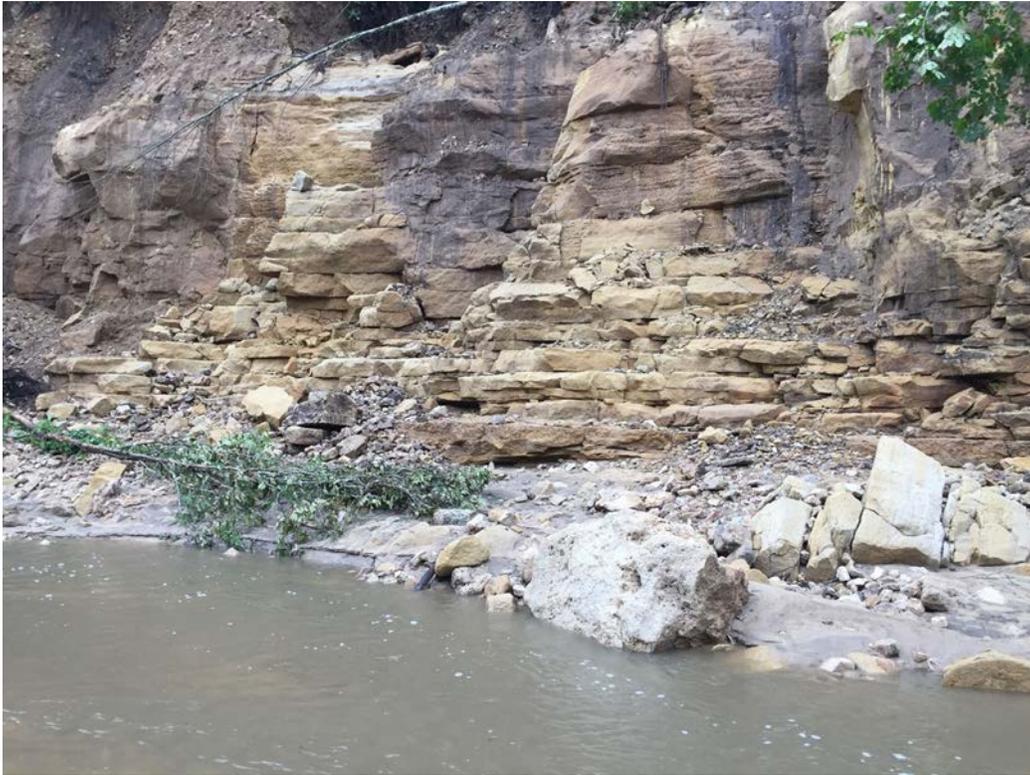
Photo 40  
View of exposed bedrock in breach channel from near upstream toe of dam.  
(CC 21)

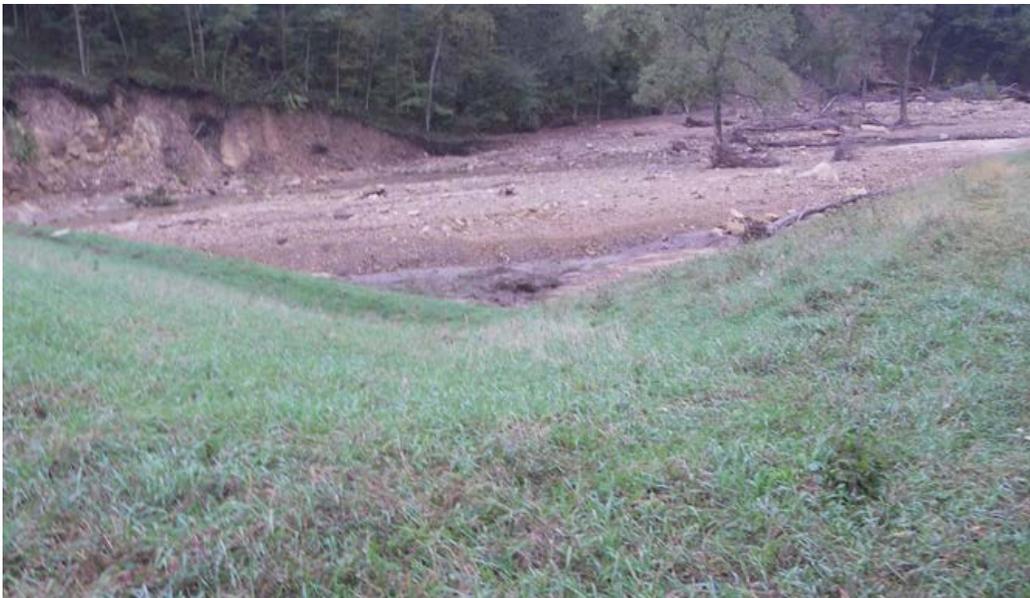
The WFK 3 left abutment provides clues why the breach eroded the bedrock rather than the embankment. The left downstream groin of WFK 3 eroded the bedrock where there was little vegetative cover. Then the headcut migrated up the groin into the soft, jointed bedrock. Like CC-21, WFK 3 had a crown with the ends sloping down to the settled top of dam (see Attachment C, CC-21, Sheet 1 of 3 and WFK 3, Sheet 1 of 4). The center of the embankment on both sites overtopped without damage. WFK 3 was probably in the early stages of a failure similar to CC-21 where the failure started in the left downstream groin. Note that the right groin, which also saw overtopping flow, did not incur any erosion (see Attachment B, Photo 41).

Photo 41  
View of right downstream groin from top of dam.  
(CC 21)

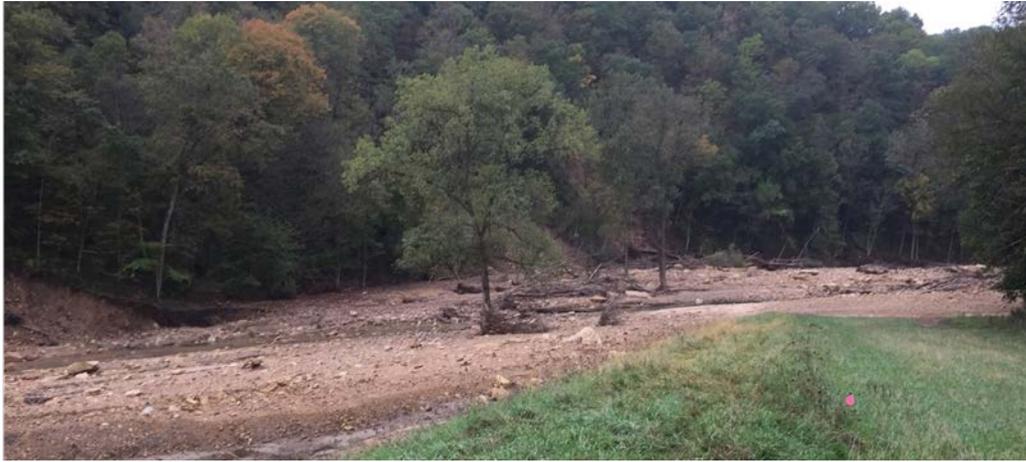
As with the other sites, it was a complete breach that cut down below the sediment pool behind the dam. Evidence of a sudden breach through the abutment bedrock can be seen in the extensive debris field downstream which consists of fragments of bedrock material (see Attachment B, Photo 42). A post-breach survey of the breach estimated the eroded material volume at 28,000 cubic yards.

Photo 42  
View downstream of dam of outwash from left abutment.  
(CC 21)

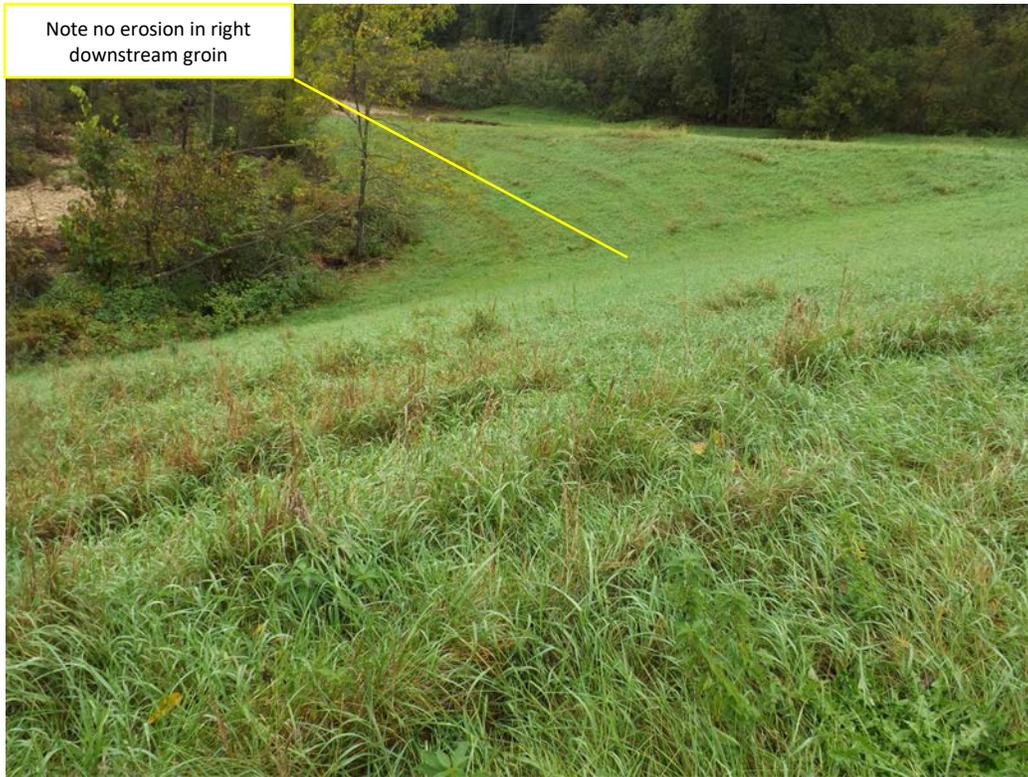
The committee traveled next to CC-29 in the afternoon. The vegetative cover on this site was excellent and overall maintenance appeared to be good (see Attachment B, Photo 43). The dam overtopped on this site and there was significant damage to the auxiliary spillway (see Attachment B, Photo 44). The auxiliary spillway is a ramped spillway with an 80 ft. wide bottom. The extent of the erosion channel, at the time of the breach, extended well over half the bottom width with a three to four-foot-deep headcut. The headcut advanced to within about 30 feet of the level section of the auxiliary spillway (see Attachment B, Photos 45 through 47). The extensive damage to the auxiliary spillway suggests that it was close to breaching at the time the breach occurred at the left end of the dam.

Photo 43  
View of downstream embankment and auxiliary spillway dike vegetation from top of dam.  
(CC 29)

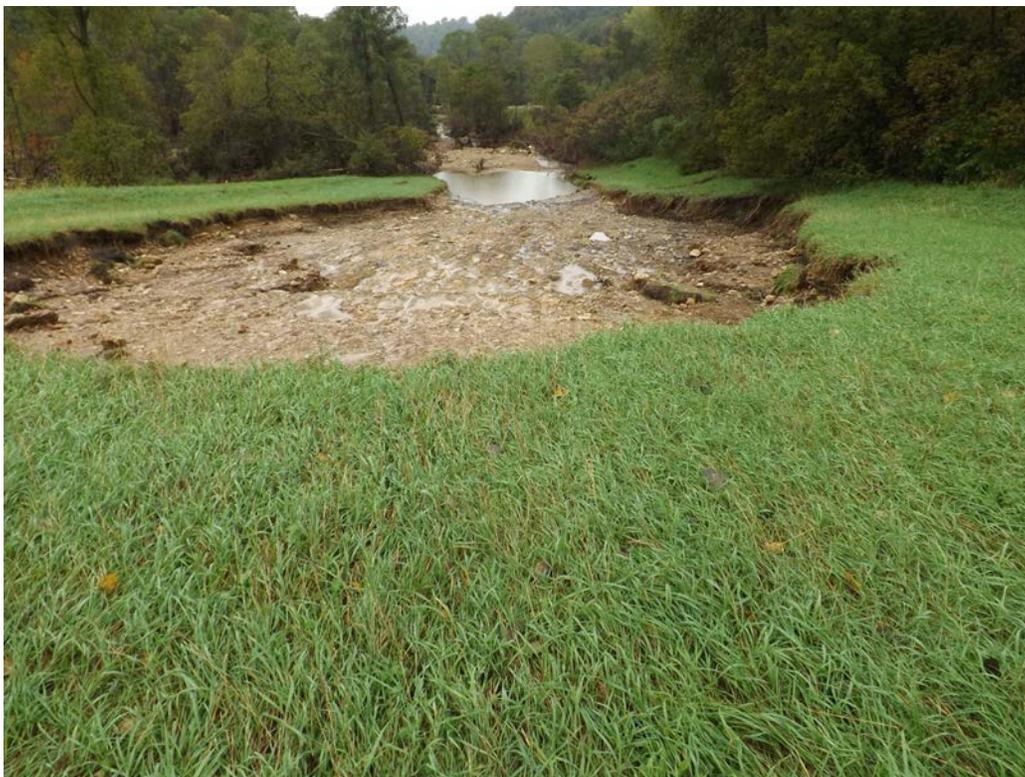
Photo 45  
View of auxiliary spillway exit channel from level section.  
(CC 29)

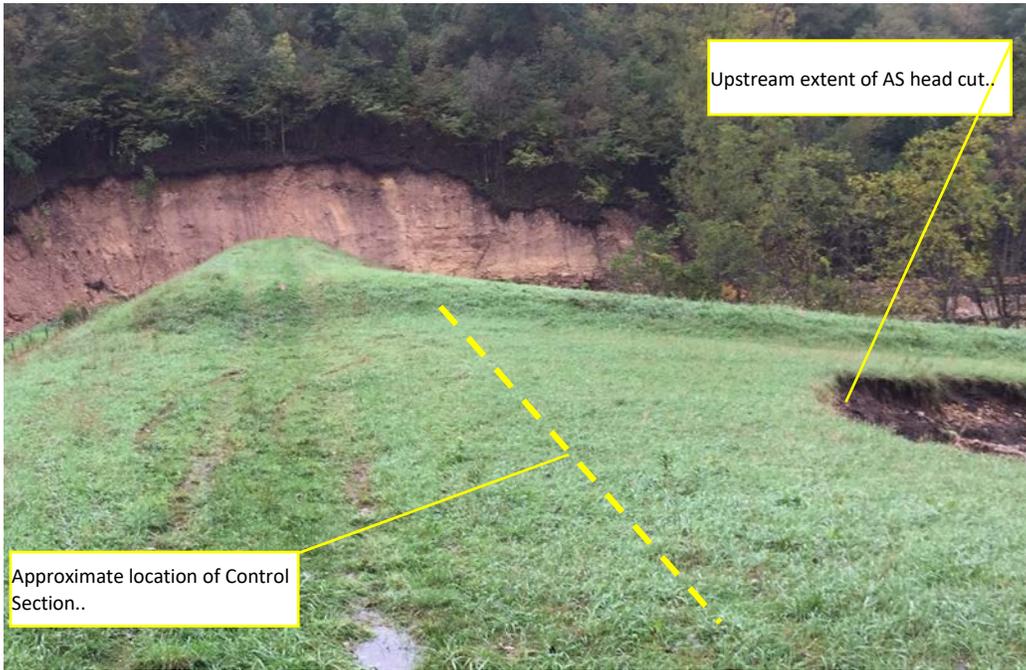
Photo 46

Approximate location of Control Section..

Upstream extent of AS head cut..

View of upstream end of auxiliary spillway from the right end of top of dam.  
(CC 29)

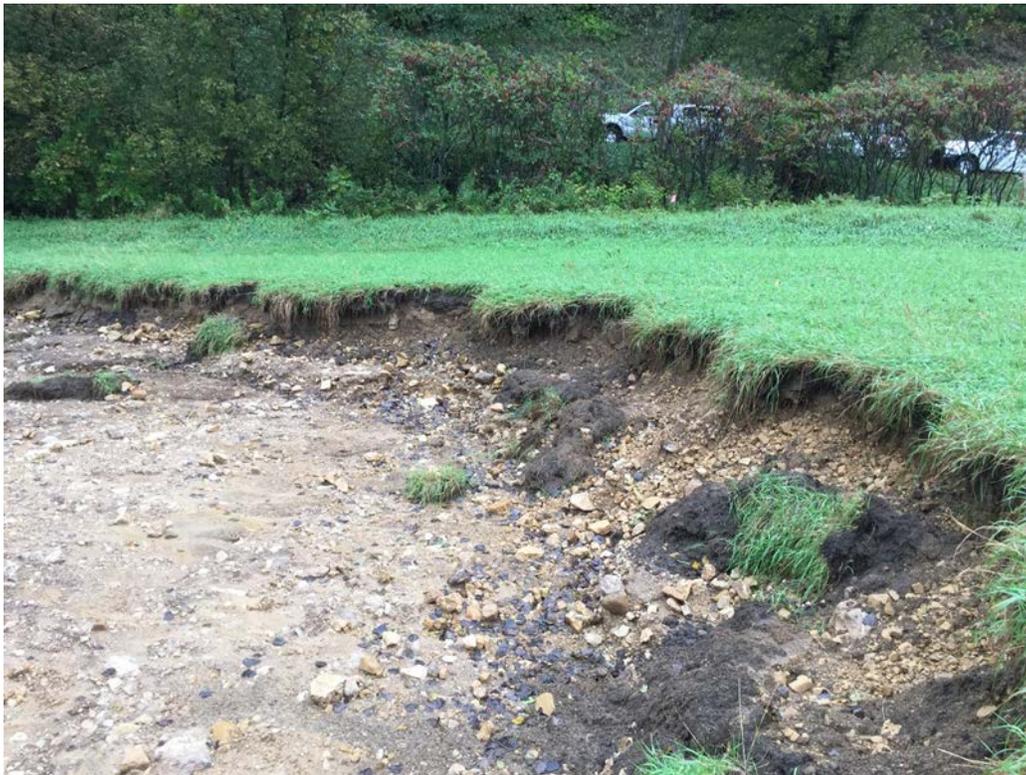
Photo 47

View of auxiliary spillway head cut from left side of channel.  
(CC 29)

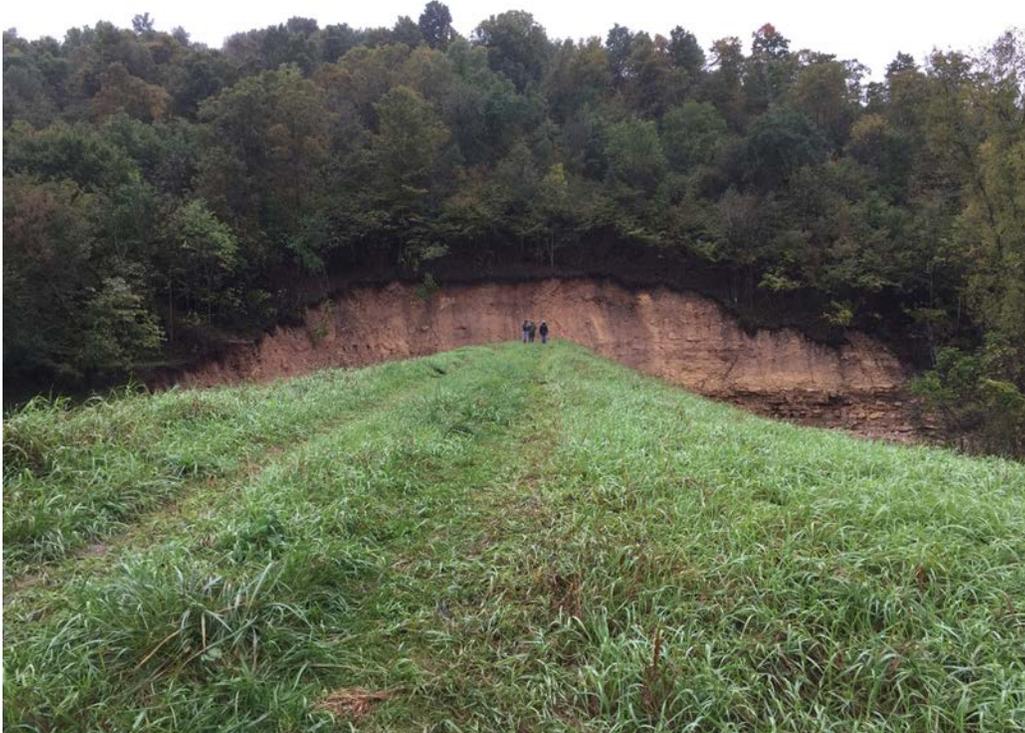
Photo 48

the ends were overtopped would the higher center of the embankment overtop, just as CC-21. The left end of CC-29 must have breached first, thereby preventing the right side from breaching (see Attachment B, Photos 48 through 52).

View of top of dam and left abutment, post-breach, from right end of dam.  
(CC 29)

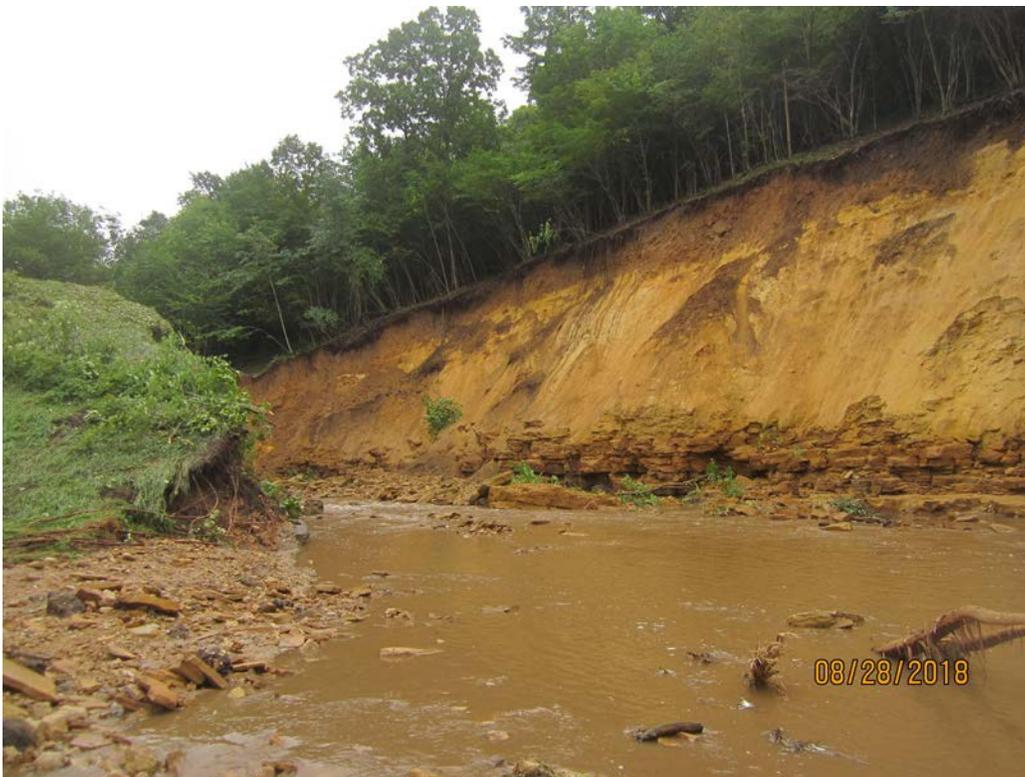
Photo 49

View of breach channel from downstream of the dam. Note photo taken the morning of the event.  
(CC 29)

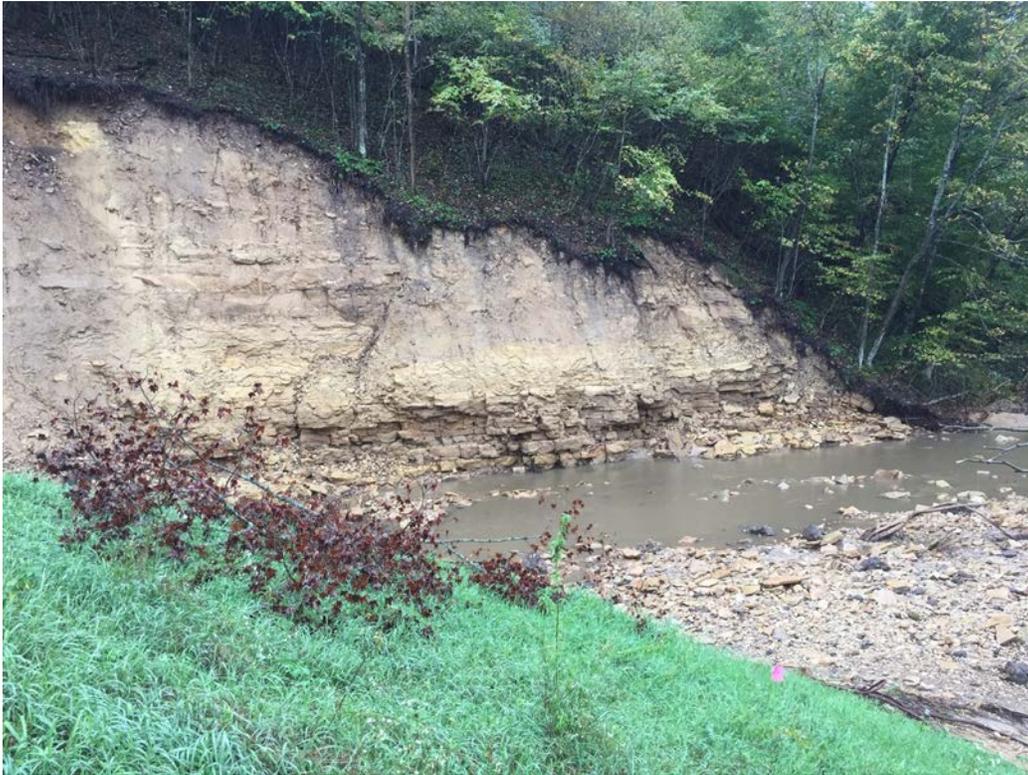
Photo 50

View of jointed and eroded bedrock in left abutment,  
downstream end of breach channel, from top of dam.  
(CC 29)

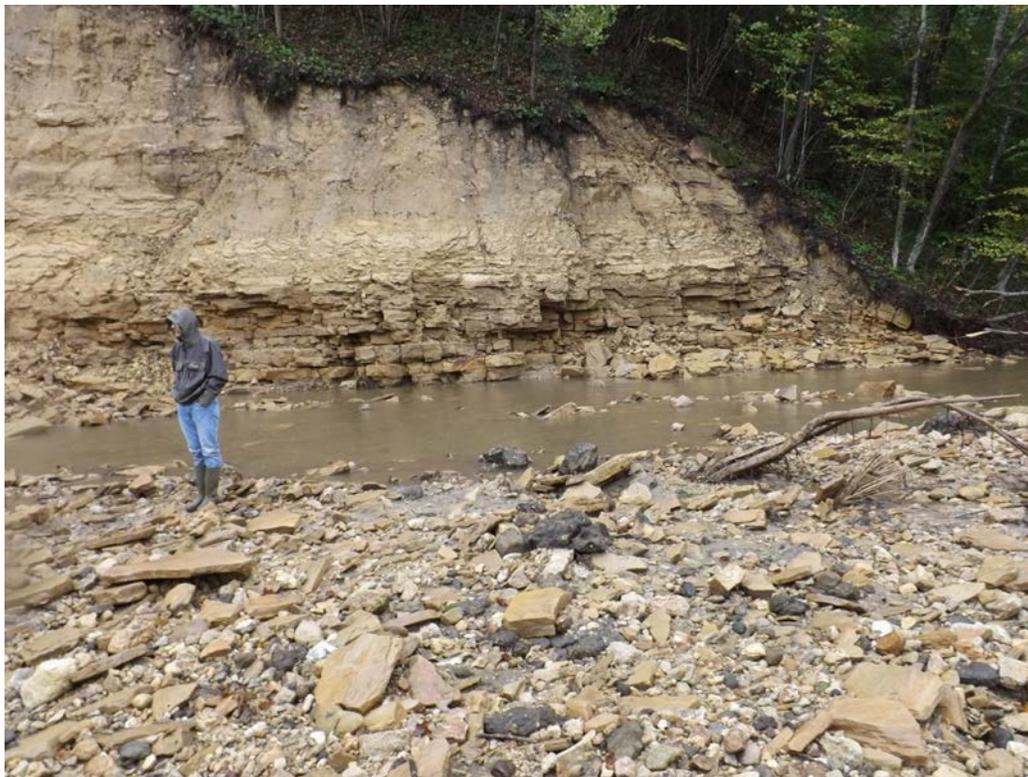
Photo 51

Close up view of left abutment bedrock in outlet end of breach channel.  
(CC 29)

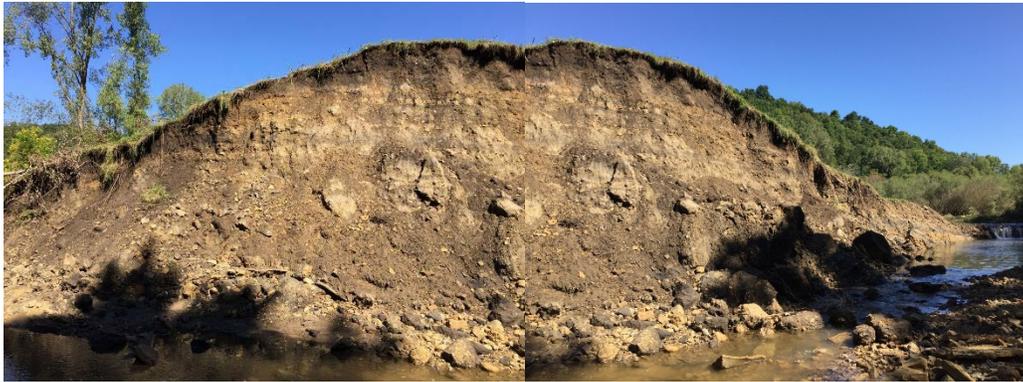
Photo 52

View of exposed end of embankment in breach channel. (CC 29)

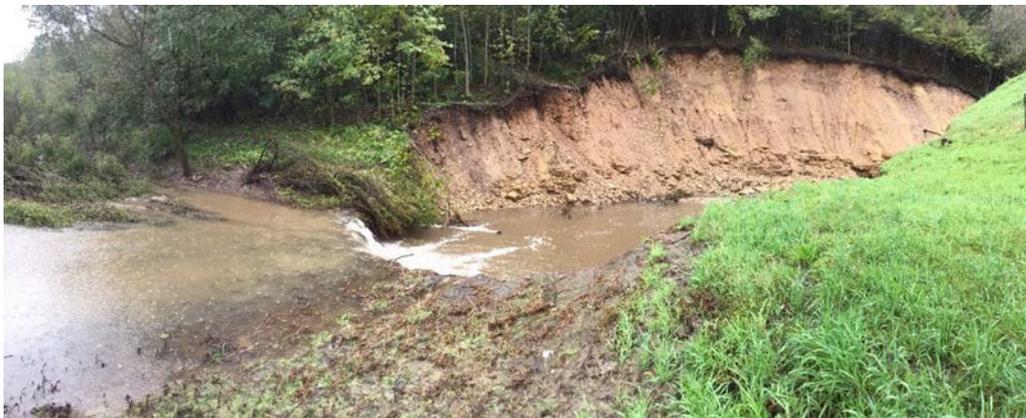
Photo 53

The breach extended below the sediment pool upstream (see Attachment B, Photo 53). The extent of erosion into the abutment was very significant (see Attachment E, CC-29, Sheet 21, Plan View and Sheet 22, Cross Section and Attachment B, Photo 44). The debris field in the breach inundation area of this site was extensive (see Attachment B, Photo 54). A post-breach survey estimated the eroded material volume at 17,000 cubic yards. The failure conditions at CC-29 are similar to those at CC-21. Refer to the narrative on CC-21 and the Geology section for more detail.

View of head cut into sediment pool from upstream toe of dam. (CC 29)

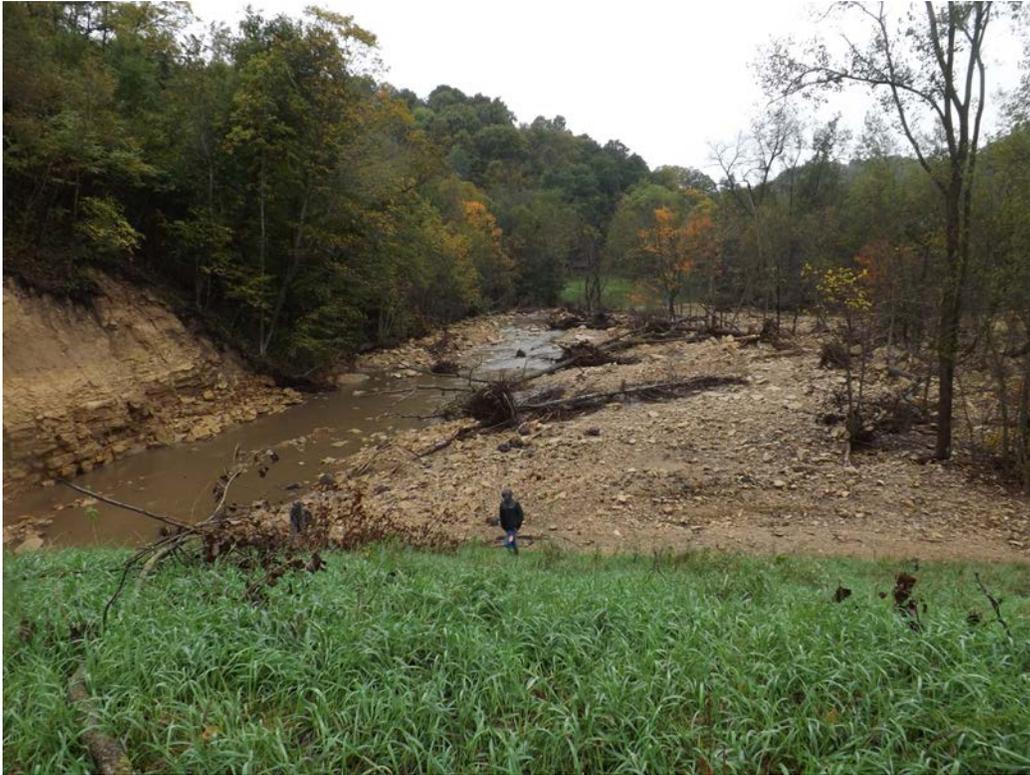
Photo 54  
View of debris in breach inundation area from top of dam.  
(CC 29)

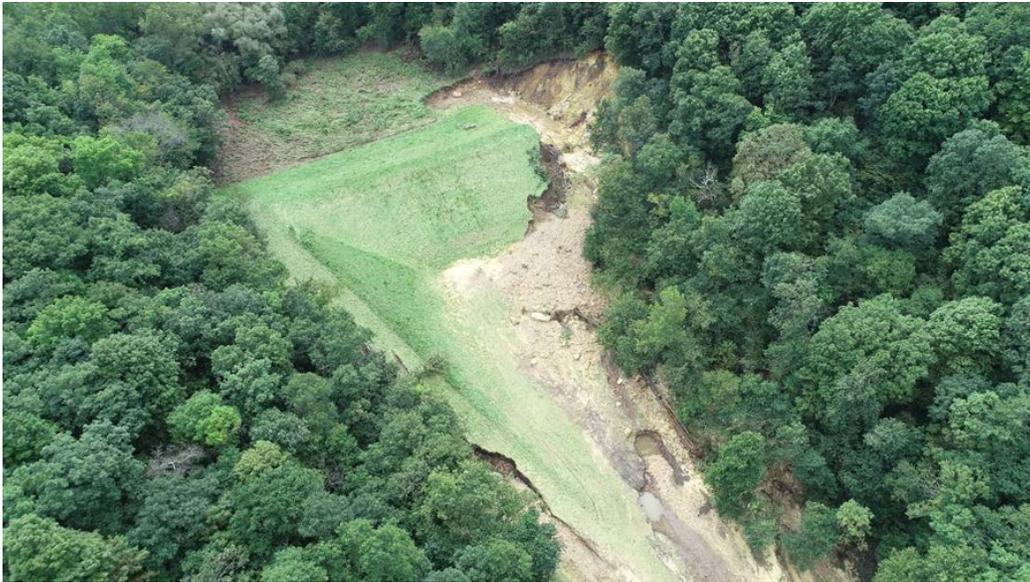
The committee traveled last to CC-23. The vegetative cover on the dam appears to be in excellent condition (see Attachment B, Photos 55 and 56). Overall maintenance appeared to be in good condition. The breach wave shifted an unoccupied ranch house off its foundation and washed out a small bridge on a town road just downstream of the house. The house is located approximately 0.4 mile downstream of the dam (see Attachment B, Photos 57 through 59).

Photo 55  
Aerial view of structure site.  
(CC 23)

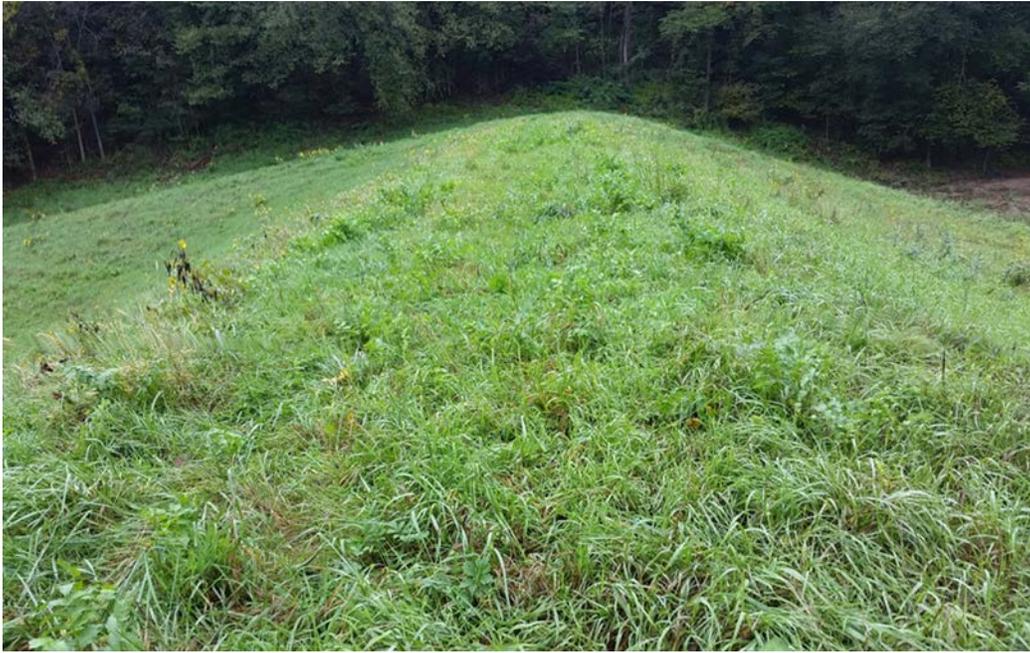
Photo 56  
View of top of embankment from top left end of dam.  
(CC 23)

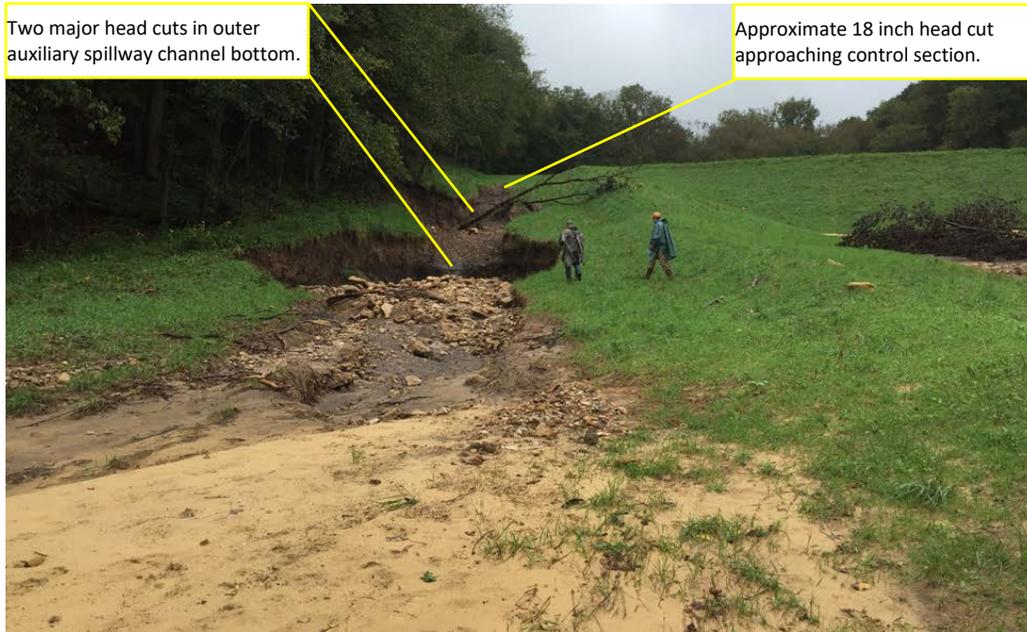
Photo 60

The dam overtopped on this site. The auxiliary spillway, a ramp spillway on the right end of the dam with a 30 ft. wide bottom, did not fail but it sustained significant erosion damage (see Attachment B, Photos 60 through 63). Two large headcuts formed in the lower 2/3 of the spillway. The depth of erosion was well into the bedrock. A smaller headcut, about 18 inches deep, advanced up the exit channel and close to the control section.

View of auxiliary spillway exit channel from downstream end. Note two large headcuts and one small headcut near control section.

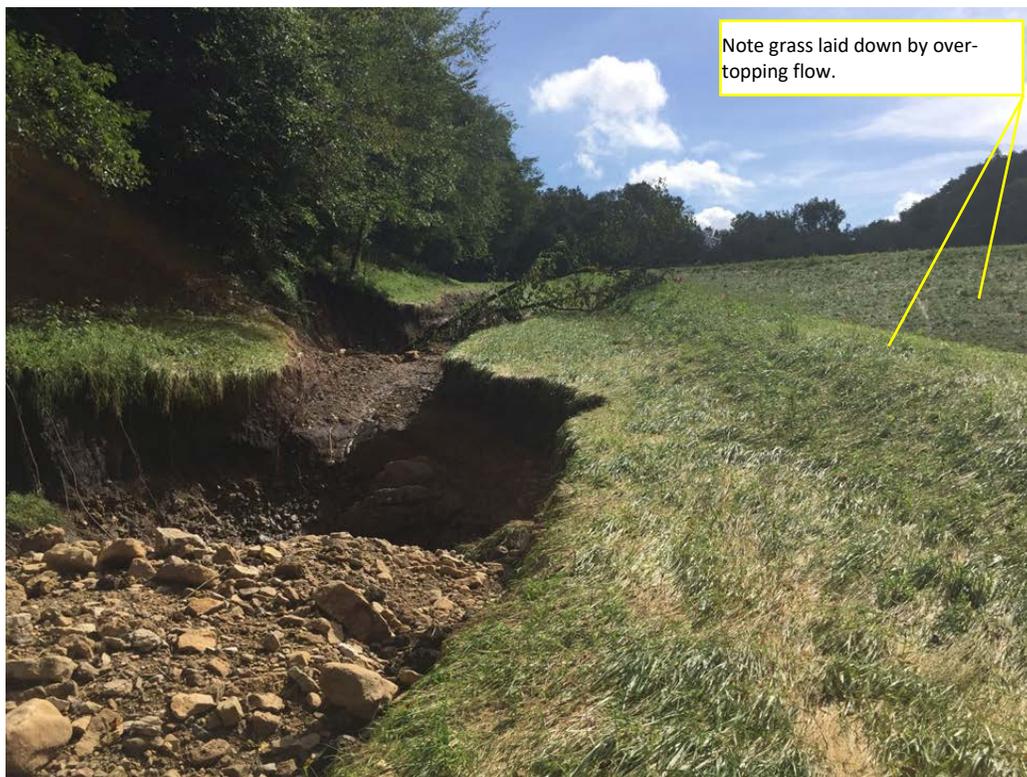
Photo 61

View of auxiliary spillway exit channel from downstream end.

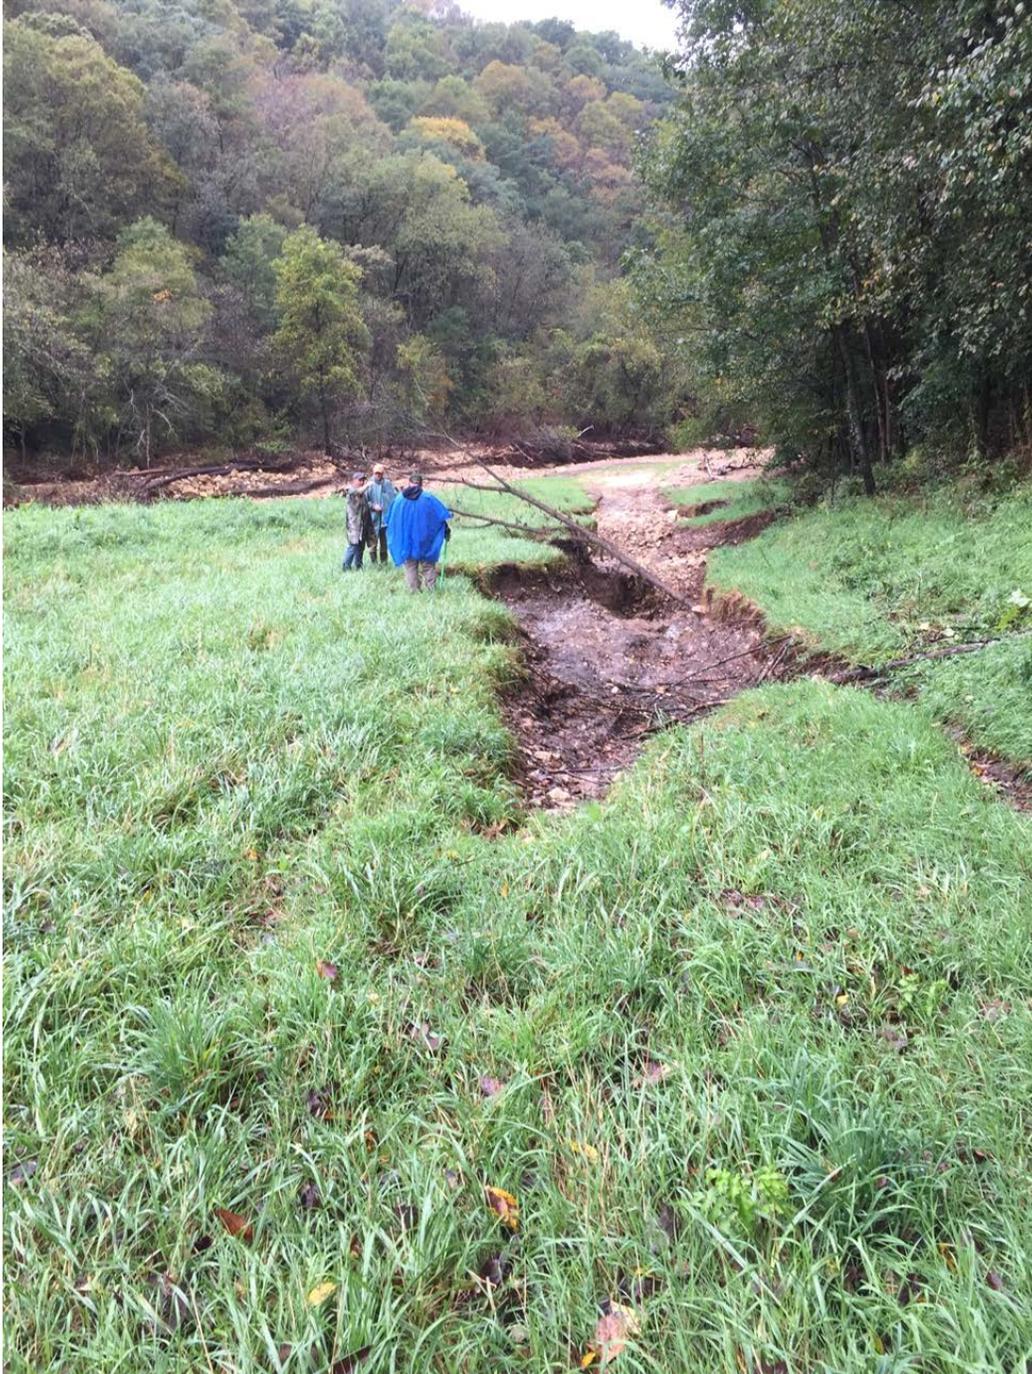
Photo 62

View of auxiliary spillway exit channel from near control section.  
(CC 23)

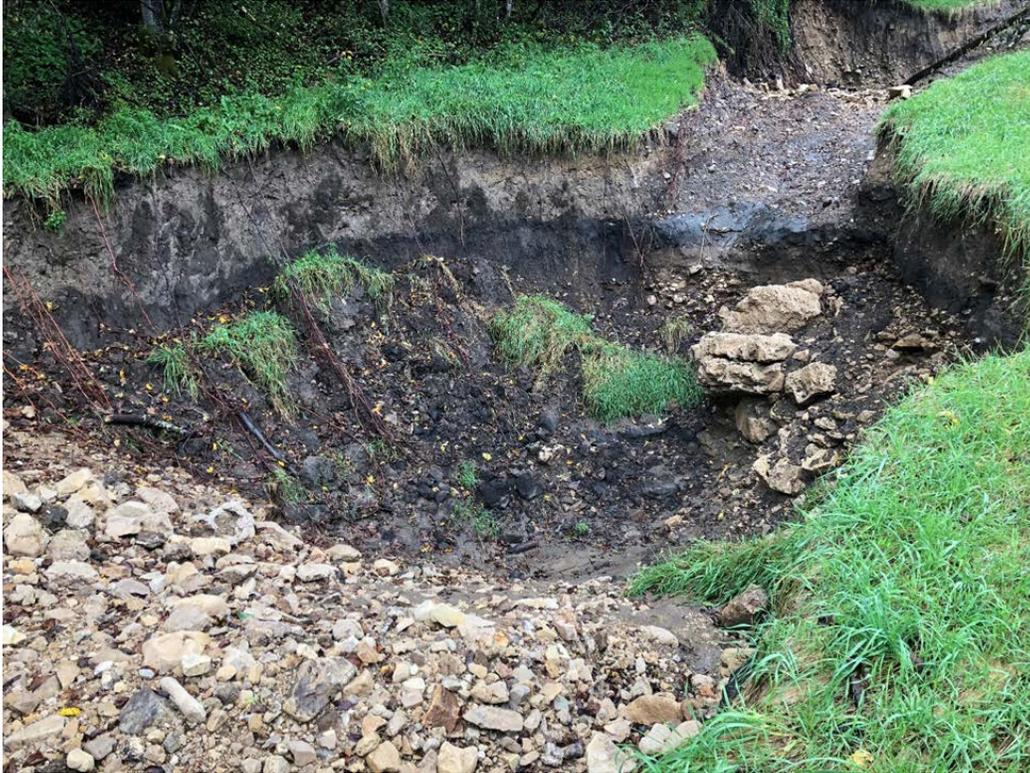
Photo 63

Close up of full depth of bottom scour hole in auxiliary spillway exit channel.  
(CC 23)

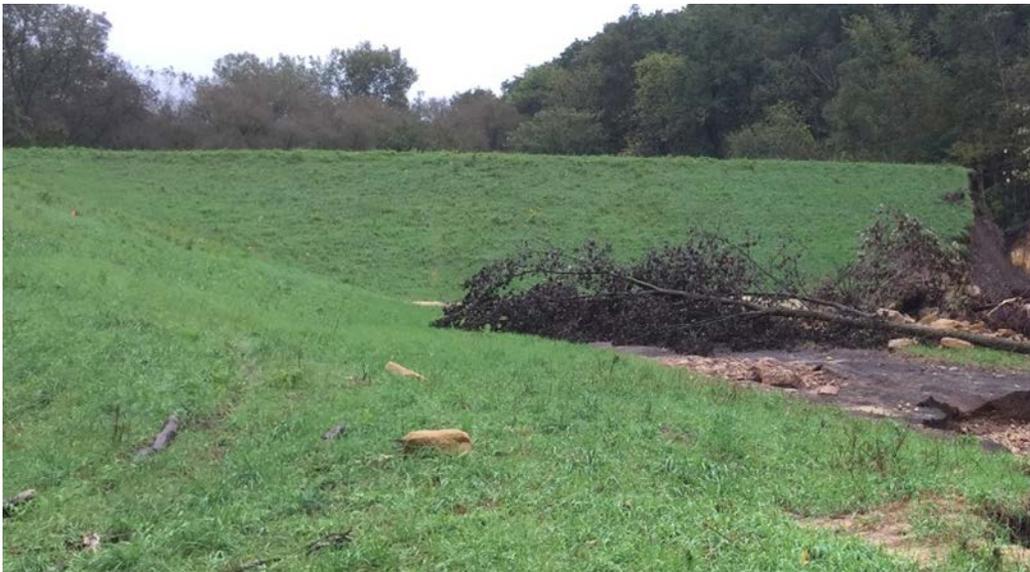
Photo 64

View of downstream side of embankment from outlet of auxiliary spillway exit channel.  
(CC 23)

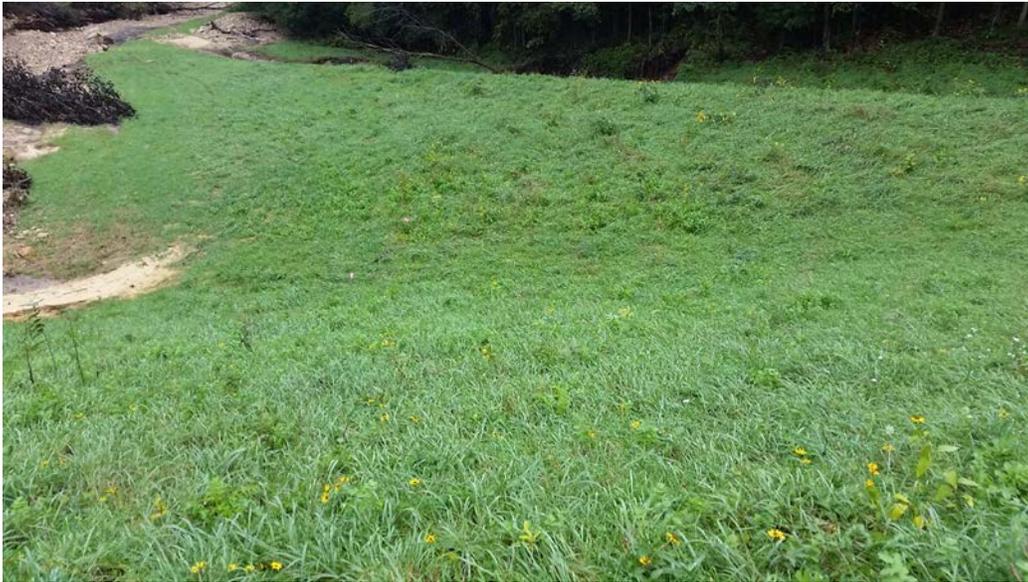
Coon Creek 23 was designed with a crowned top of dam, about 1.75 feet. However, the LiDAR data shows that the crown may have settled out as the top of dam appears to be nearly level (see Attachment E, CC-23, Sheet 17, Cross Section). If so, the overtopping flow would have occurred across the entire length of dam at approximately the same depth. There was no observed erosion on the downstream side of the main embankment (see Attachment B, Photos 55 and 64). While flow may have been evenly distributed over the dam, the breach of the left groin appears to have been similar to the failures at CC-21 and CC-29. There was no failure of vegetation in the right groin which is all compacted earthfall (see Attachment B, Photo 65)

Photo 65  
View of right groin from top of dam.  
(CC 23)

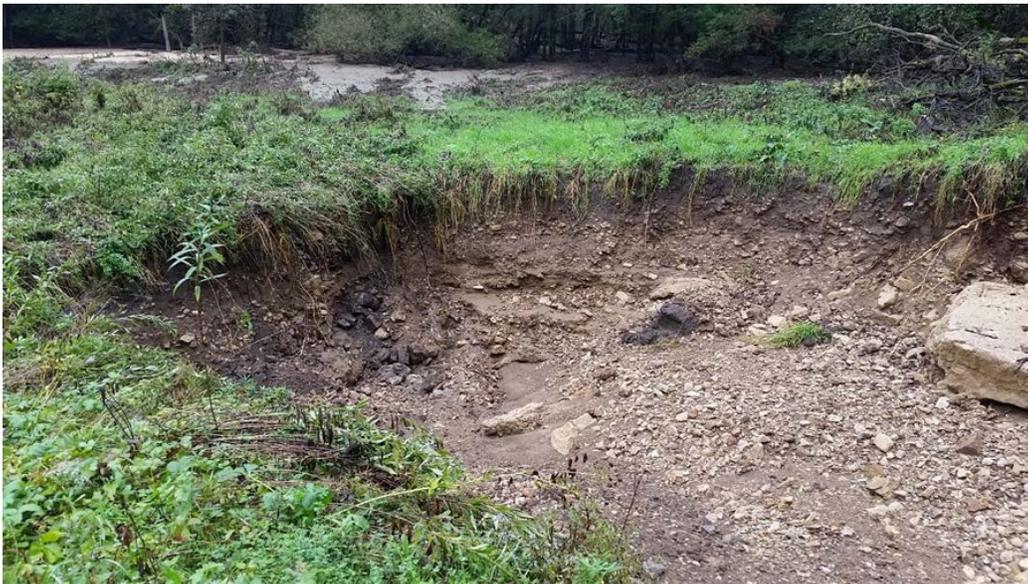
The breach eroded below the sediment pool upstream (see Attachment B, Photo 66). The erosion significantly extended into the abutment (see Attachment E, CC-23, Sheet 16, Plan View and Sheet 17, Cross Section, and Photos 67 through 69). A headcut approximately six feet deep eroded the bedrock at the bottom of the breach channel (see Attachment B, Photos 71 and 72). The exposed bedrock at this site revealed the widest vertical valley relief fractures

Photo 66  
Head cut into upstream sediment pool due to breach of dam.  
(CC 23)

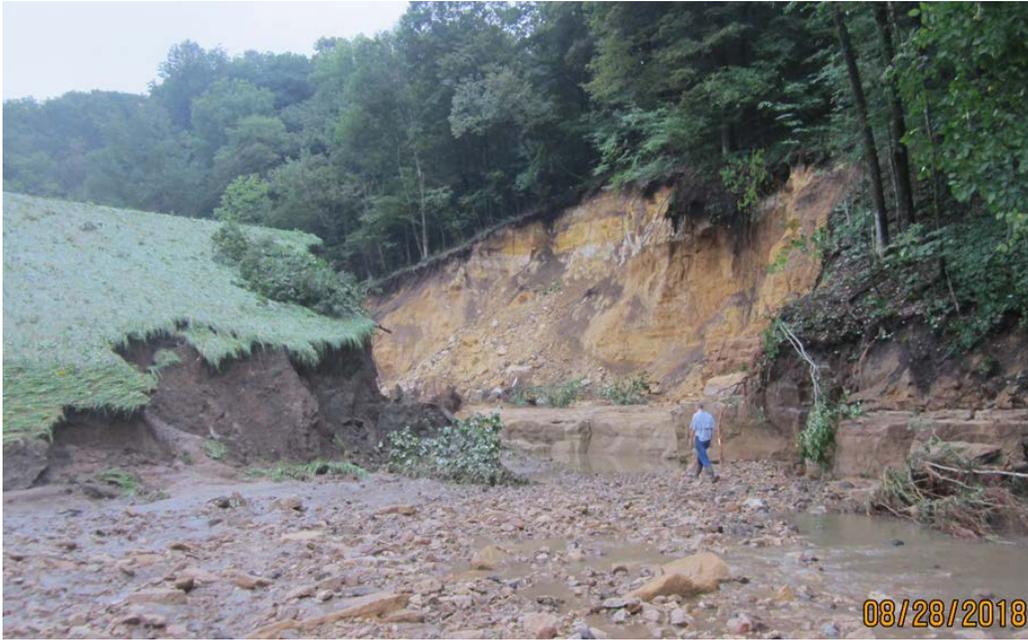
Photo 67  
View of breach channel from downstream of dam.  
(CC 23)

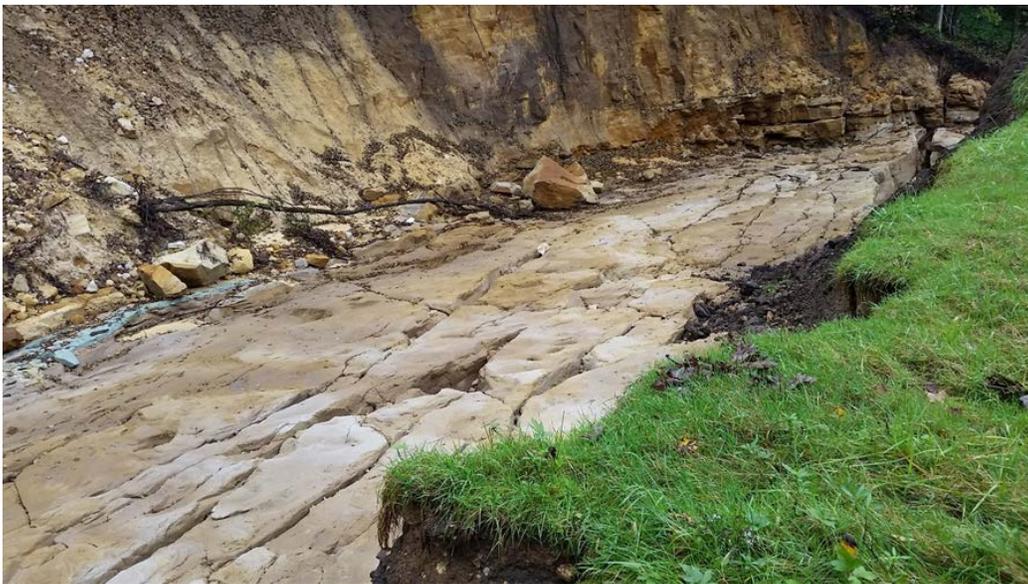
Photo 68  
View of breach channel from upstream toe of dam.  
(CC 23)

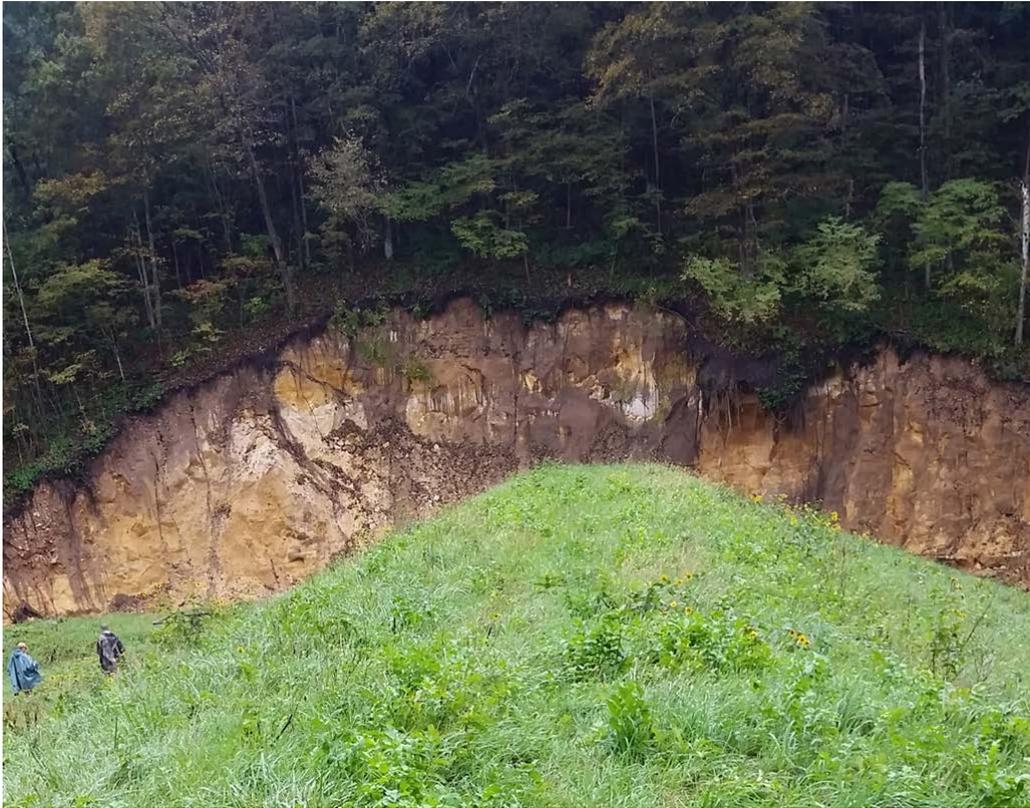
Photo 69  
View of exposed bedrock in left abutment – breach channel.  
(CC 23)
