INVESTIGATION REPORT FOR COON CREEK WATERSHED STRUCTURES 21, 23, AND 29,  
AND WEST FORK KICKAPOO WATERSHED STRUCTURES MLSNA AND 1  
MONROE AND VERNON COUNTIES, WISCONSIN

U.S. DEPARTMENT OF AGRICULTURE  
NATURAL RESOURCES CONSERVATION SERVICE

June 26, 2019

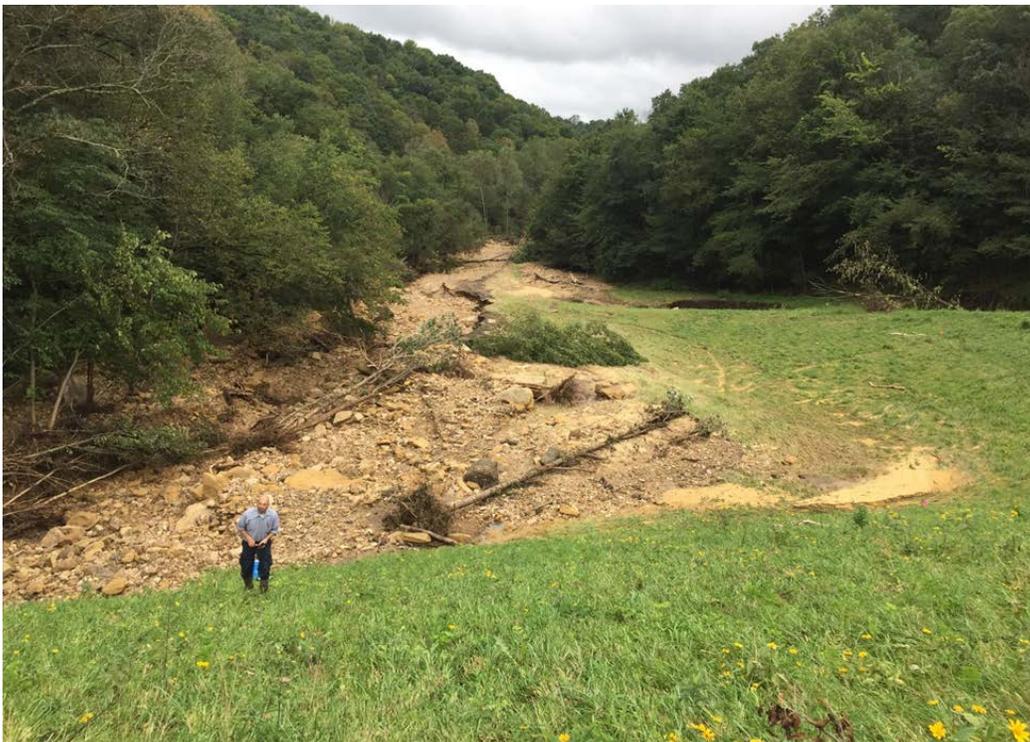
of any of the sites (see Attachment B, Photos 71 through 73). The debris field in the breach inundation area of this site was extensive (see Attachment B, Photo 70). A post-breach survey estimates the eroded material volume at 15,000 cubic yards. The failure conditions at CC-23 are similar to CC-21. Refer to the narrative on CC-21 and the Geology section for more detail.

Photo 70  
View of debris in breach inundation area downstream of dam.  
(CC 23)

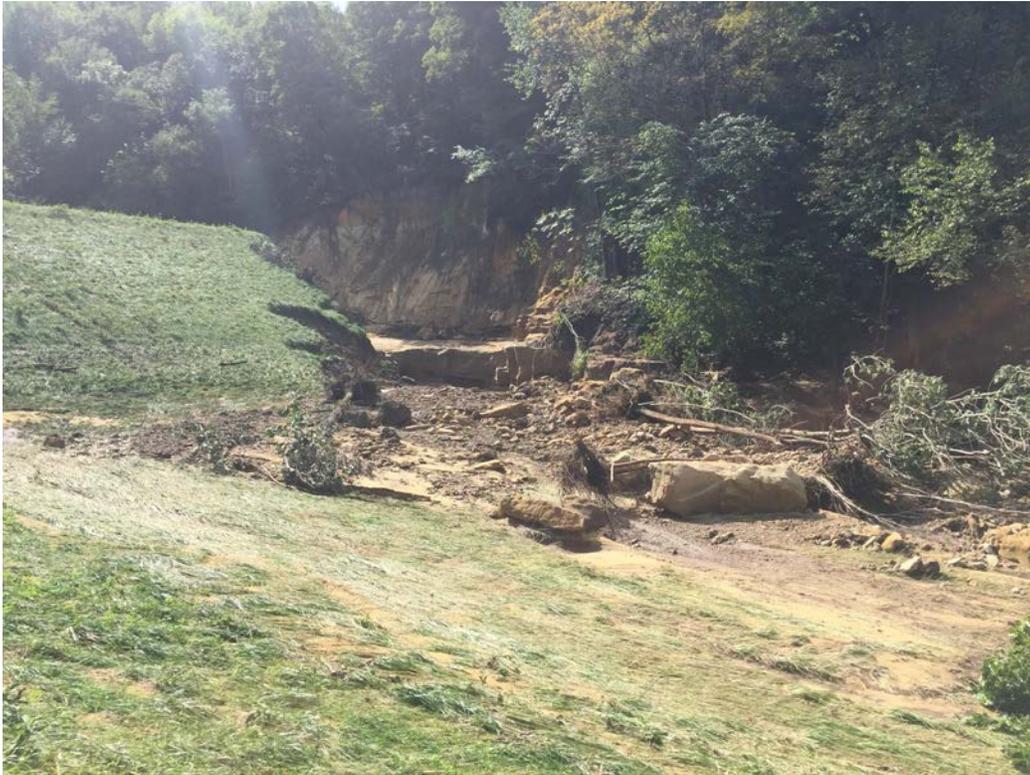
The breach eroded below the sediment pool upstream (see Attachment B, Photo 66). The erosion significantly extended into the abutment (see Attachment E, CC-23, Sheet 16, Plan View and Sheet 17, Cross Section, and Photos 67 through 69). A headcut approximately six feet deep eroded the bedrock at the bottom of the breach channel (see Attachment B, Photos 71 and 72). The exposed bedrock at this site revealed the widest vertical valley relief fractures

Photo 71  
View of head cut into bedrock of breach channel.  
(CC 23)

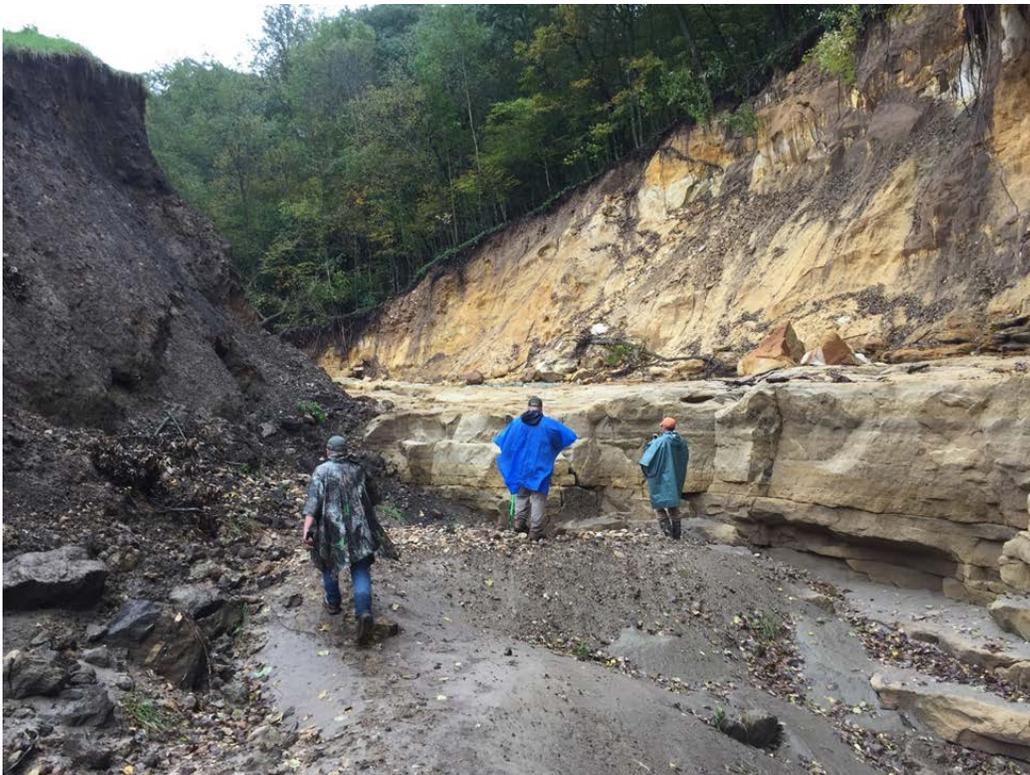
Photo 72  
Close up view of head cut into bedrock of breach channel.  
(CC 23)

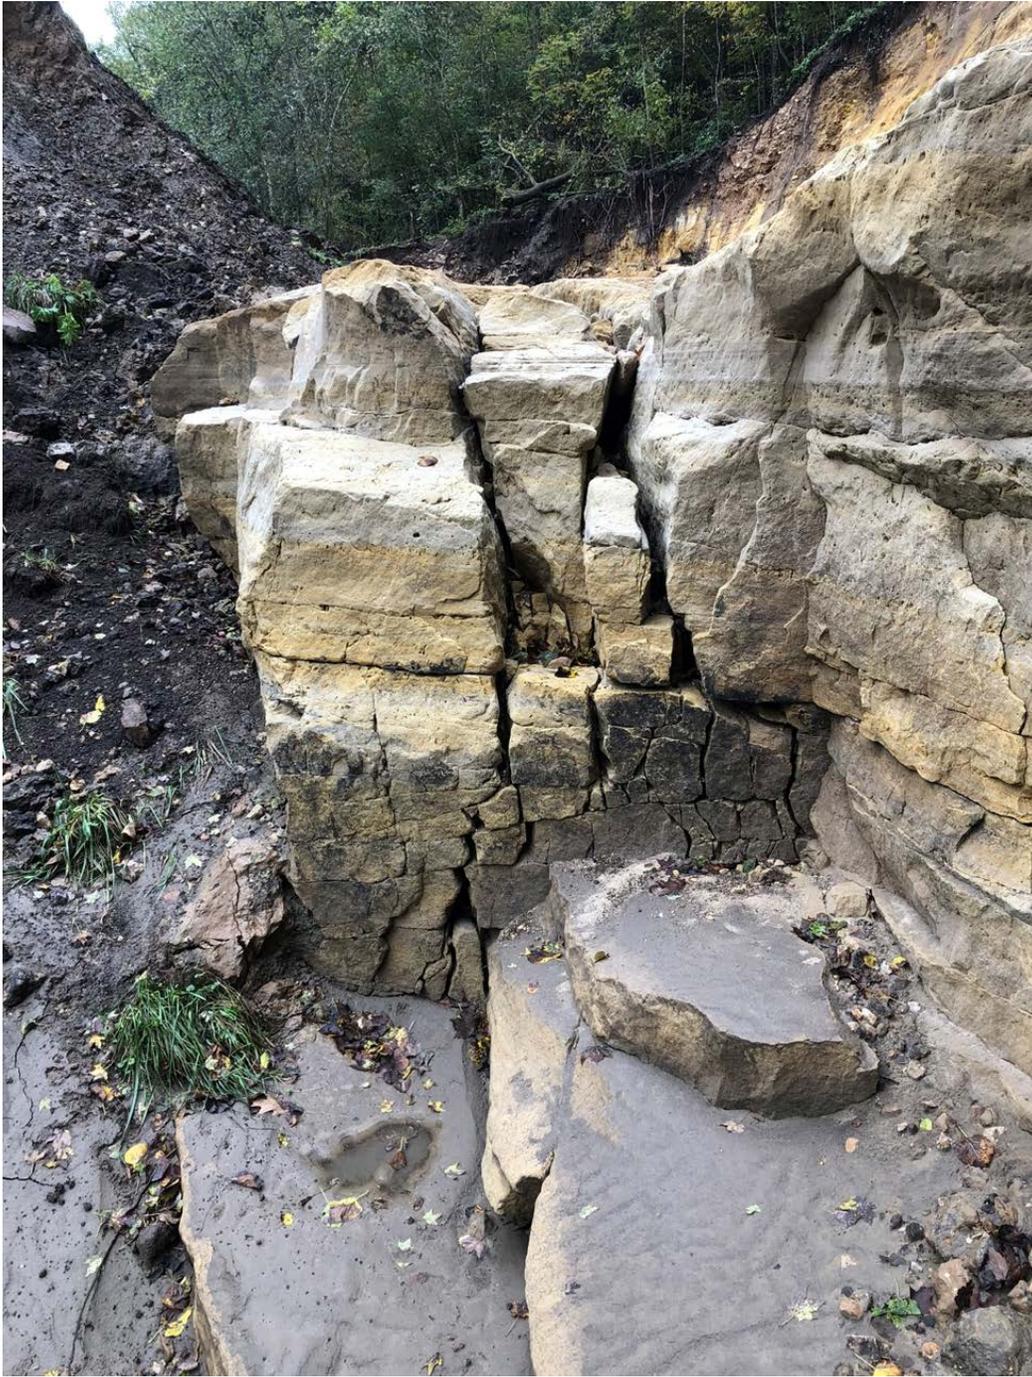
Photo 74  
Close up view of vertical valley relief fracture.  
(CC 23)

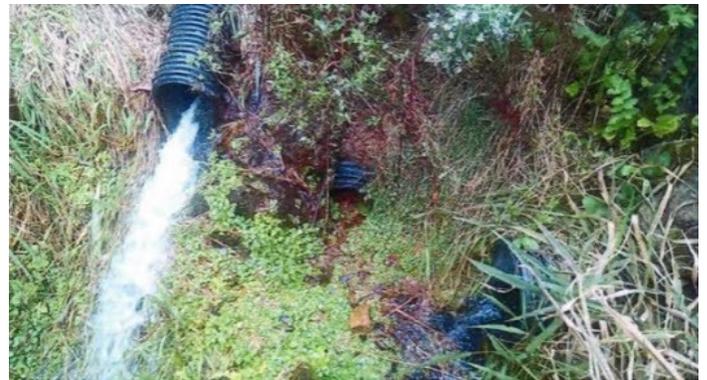
Seepage from Right Abutment Drains

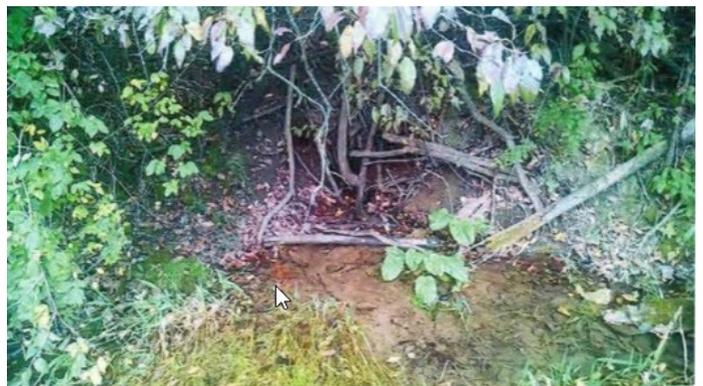
Seepage from Right Abutment Bedrock

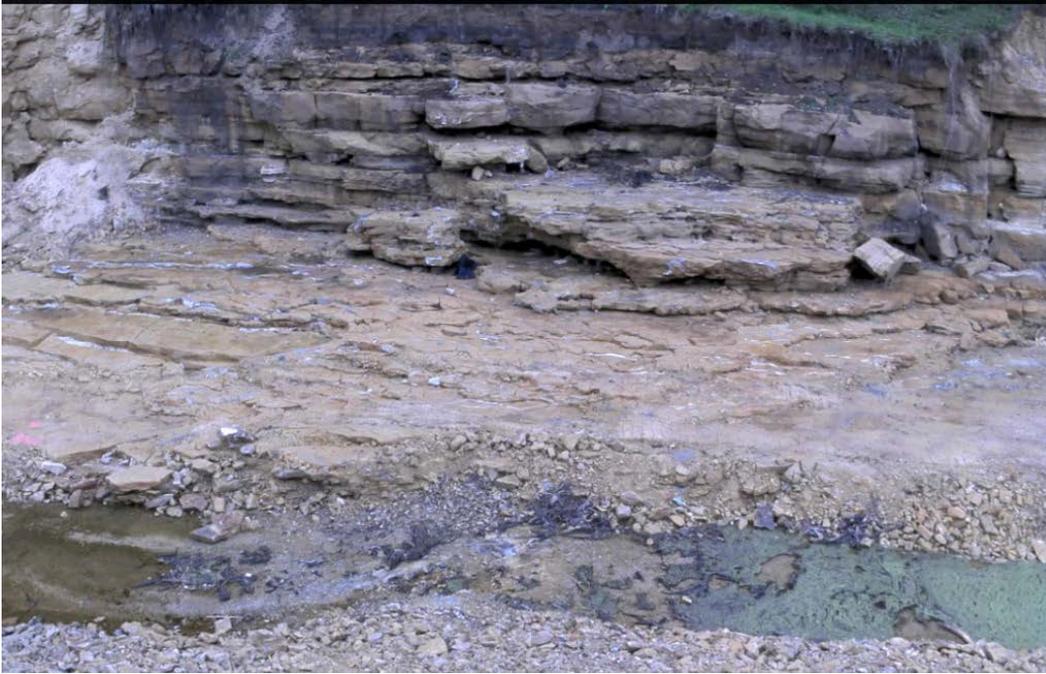
Photo 1  
Typical exposure of bedrock in breach channel.  
(WFK 1)
